WILD TROUT TRUST  
wildtrout.org

## Advisory Visit River Sid, Devon

April 19, 2021

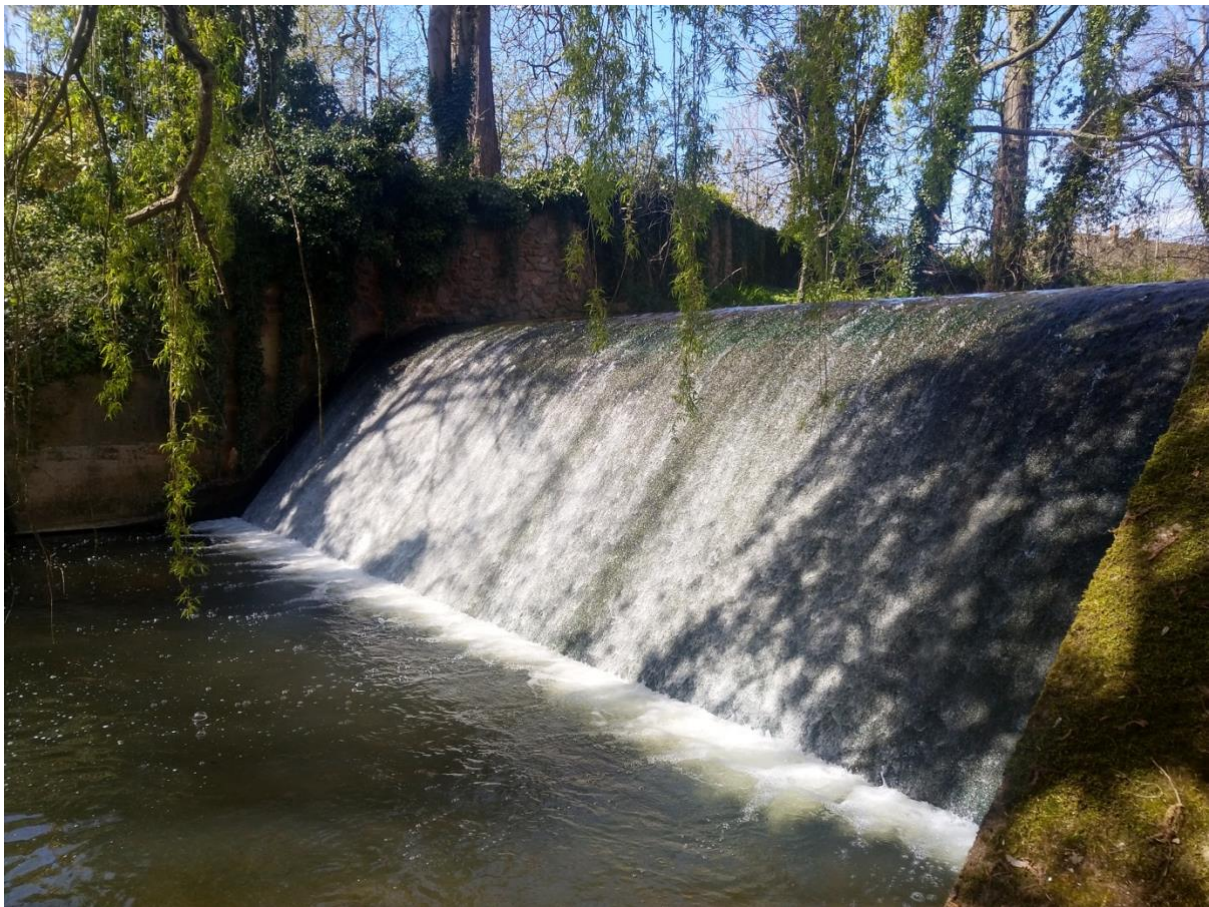
*Figure 1 School Weir*

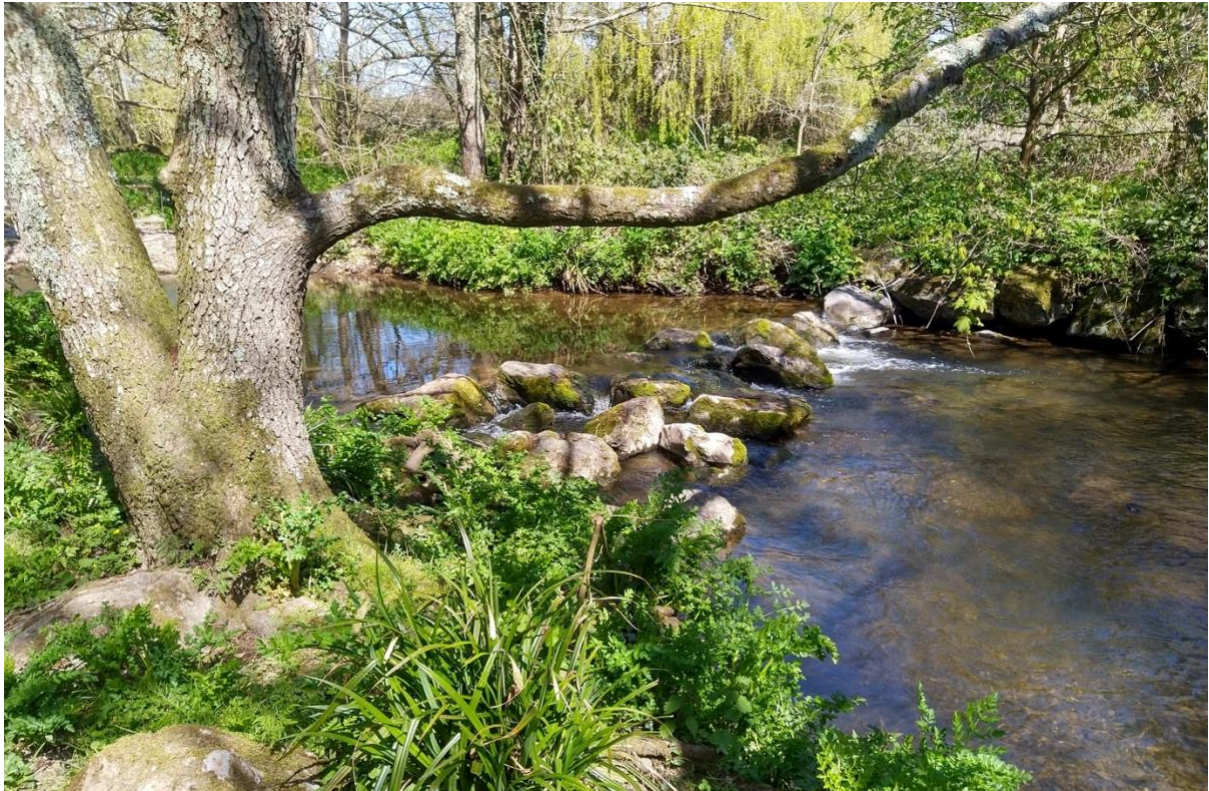
*Figure 3 The first boulder weir immediately upstream of another at Figure 4. This should be altered with an aim to provide general roughness, over the appearance of a weir. SY 13304 88965*

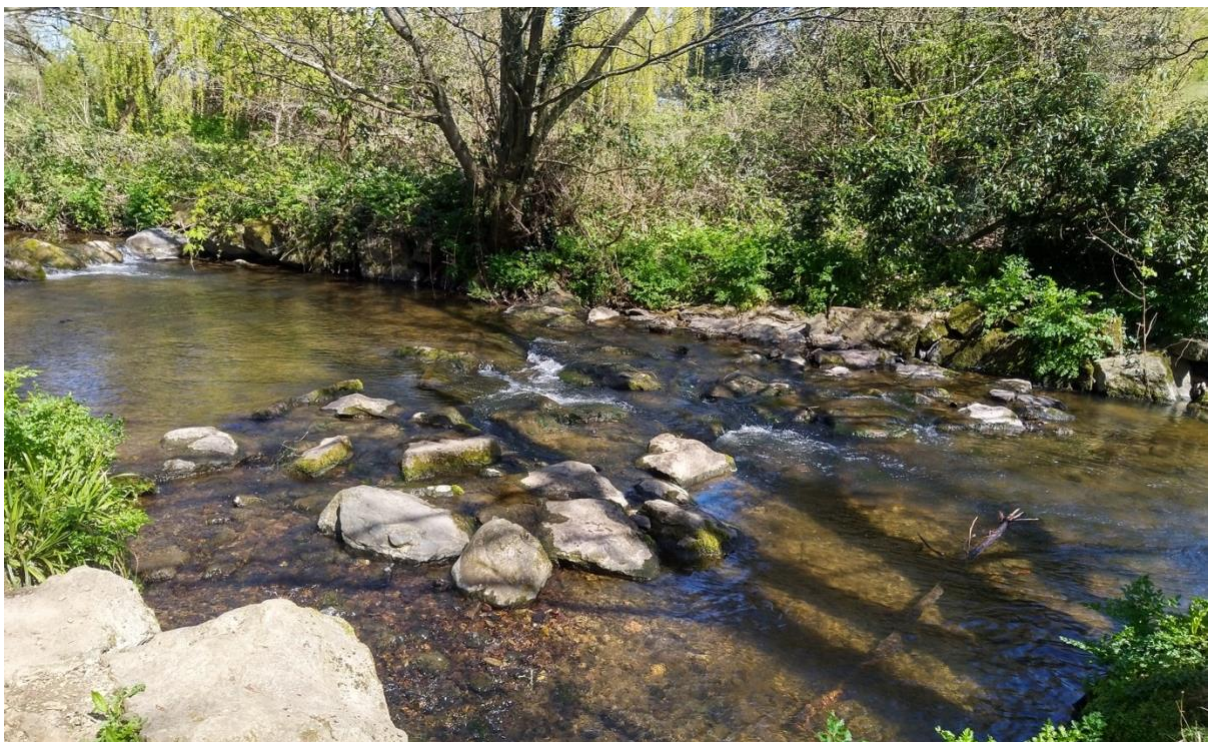
*Figure 4 Immediately downstream of Figure 3 (visible top left), a more sympathetic artificial riffle. Though better, it could still benefit from manipulation. SY 13307 88965*

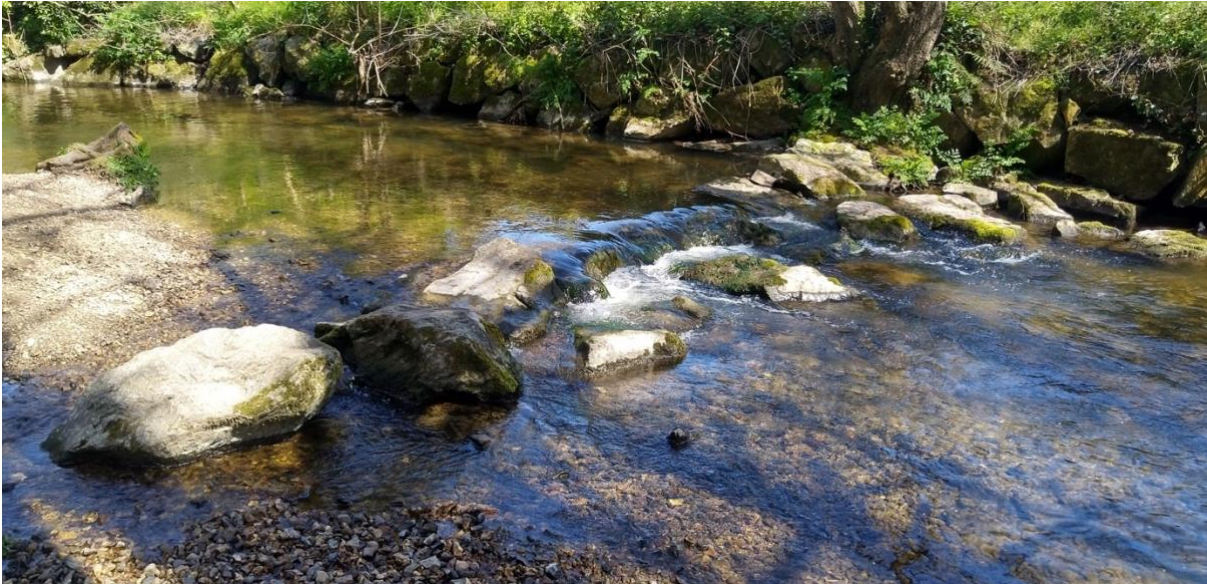
*Figure 5 Another boulder weir. Simply encouraging low flows around the last boulder on the RB (nearest to camera) would begin a meander while still allowing high flows to pass over the top. SY 13307 88965*

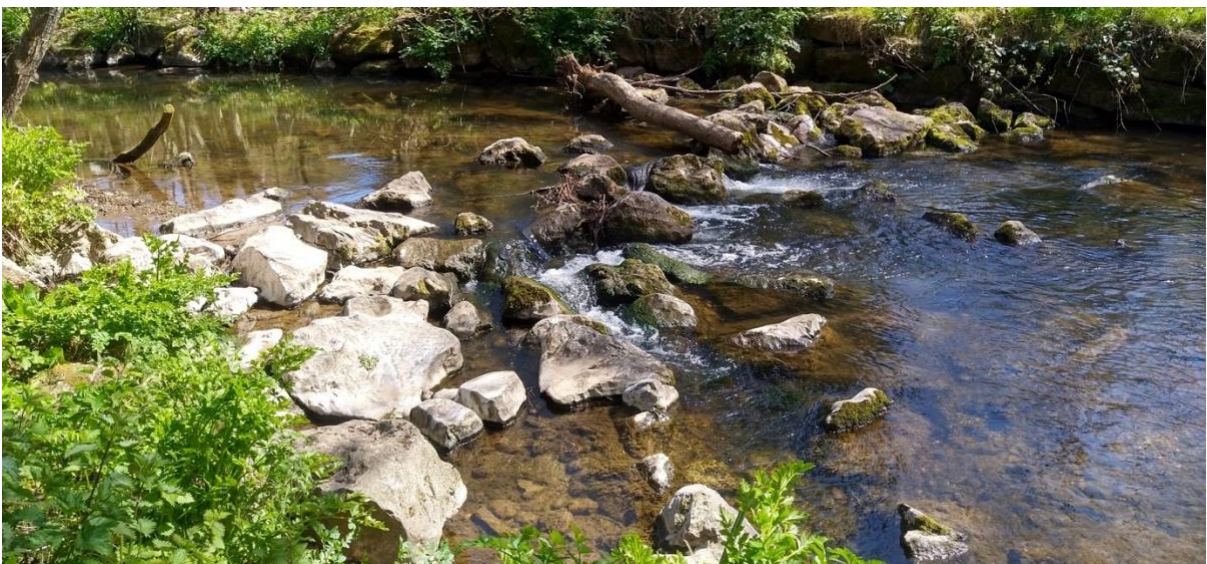
*Figure 6 Another boulder weir. Note the uniform depth and sediment upstream compared to the diverse depth and substrate downstream. Such uniformity increases the risk of smolt predation by piscivorous birds. SY 13289 88913*

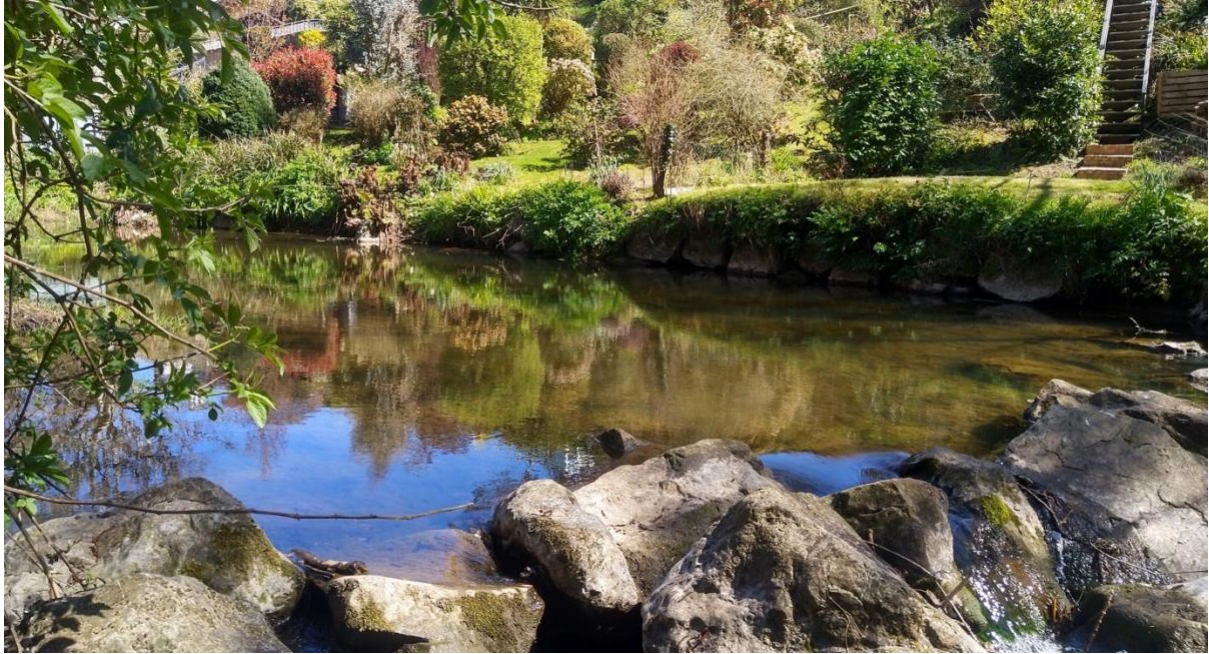
*Figure 9 Another boulder weir. Note the impoundment of the river above and the stone revetment of the garden banks. This calm water may be seen as desirable for the bankside gardens but is detrimental for the habitat. SY 13171 88701*

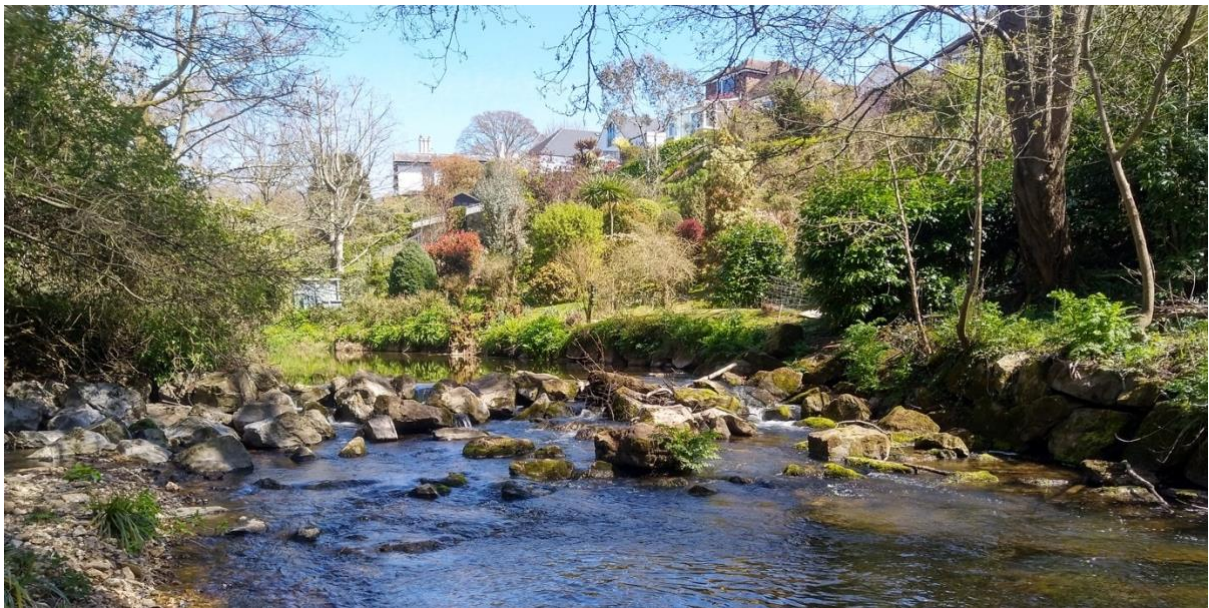
*Figure 10 Easing of this boulder weir will increase the pace of flow in the impoundment by the gardens (as seen in Figure 9). Work will be needed to prevent erosion of their banks, but the river course could be encouraged toward the RB. SY 13171 88701*

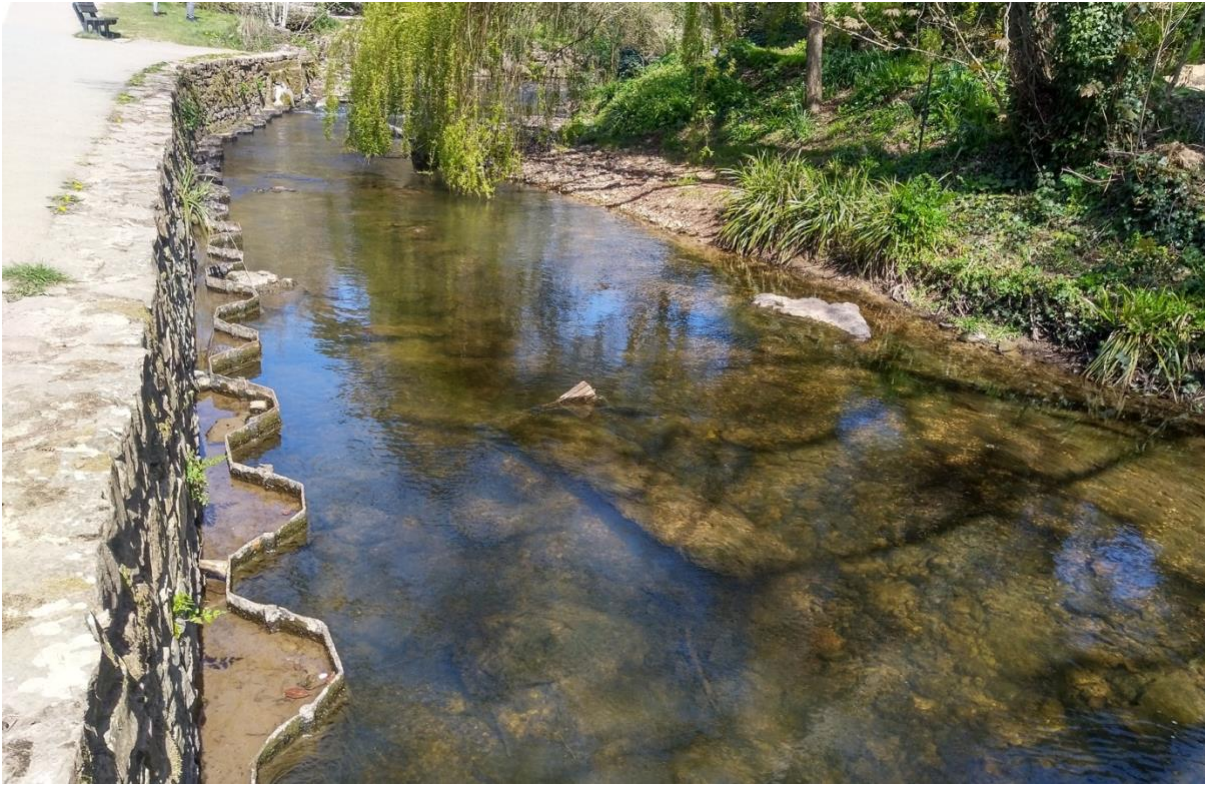
*Figure 13 Hard sheet piling revetment prevents the footpath from eroding. Reducing stream energies upstream will allow for a softer, greener bank to be installed. Note the smothered gravels caused by the impoundment of the old weir downstream. SY 12963 88595*

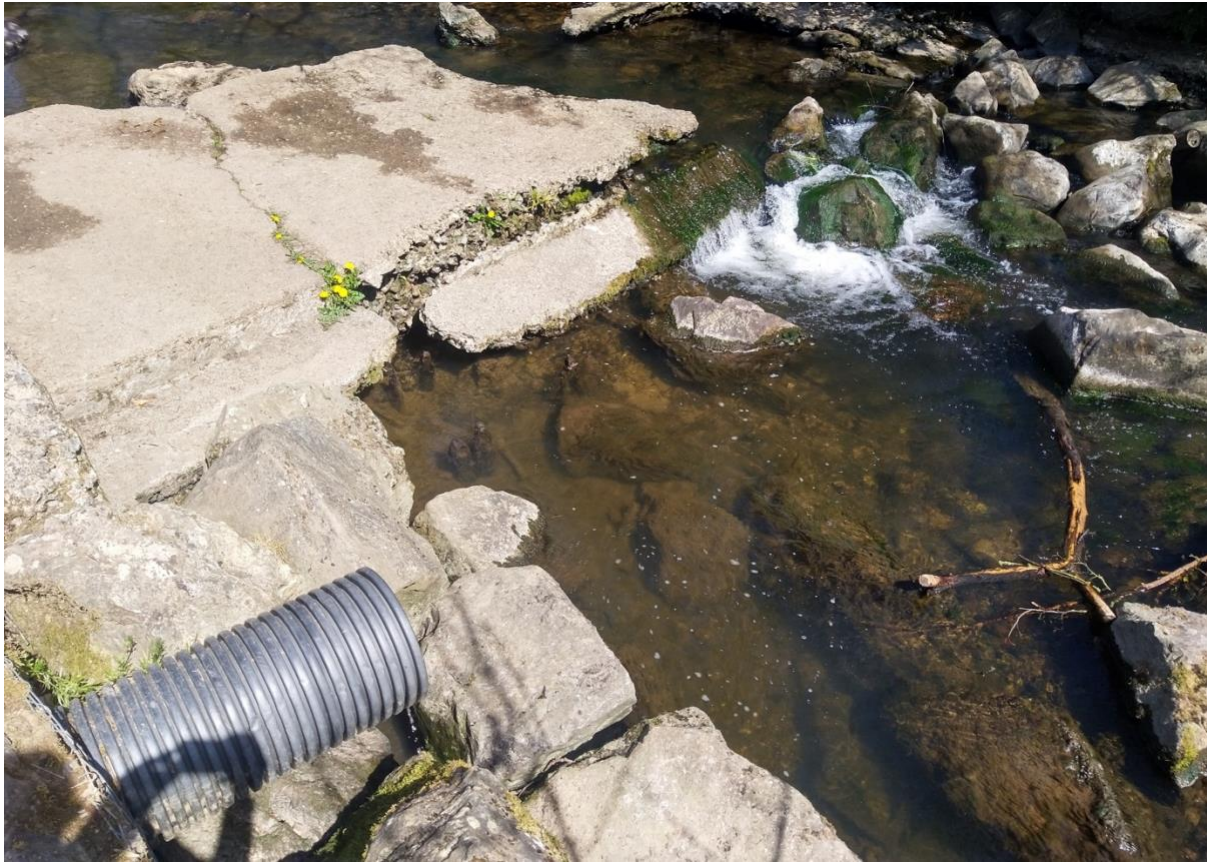
*Figure 15 Sewer Storm Overflow Permit No: 201828 no spill duration monitoring available. Algal growth suggesting excessive nutrients in this area. SY 12956 88575*

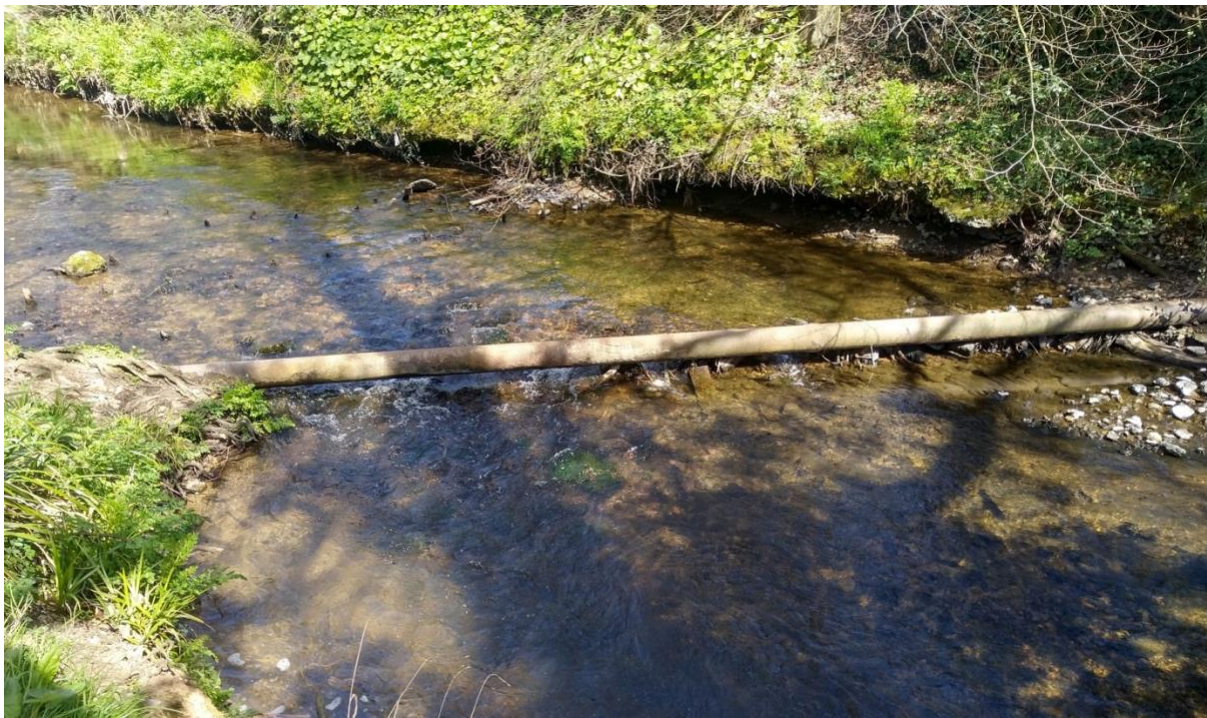
*Figure 16 A sewerage pipe crosses the river. With high flow velocities common, this is vulnerable to fracture by passing debris. The asset owner is liable for the environmental damage such a fracture will undoubtedly cause downstream. Liaison with the owner to find a re-routing solution is advised. SY 12977 88539*

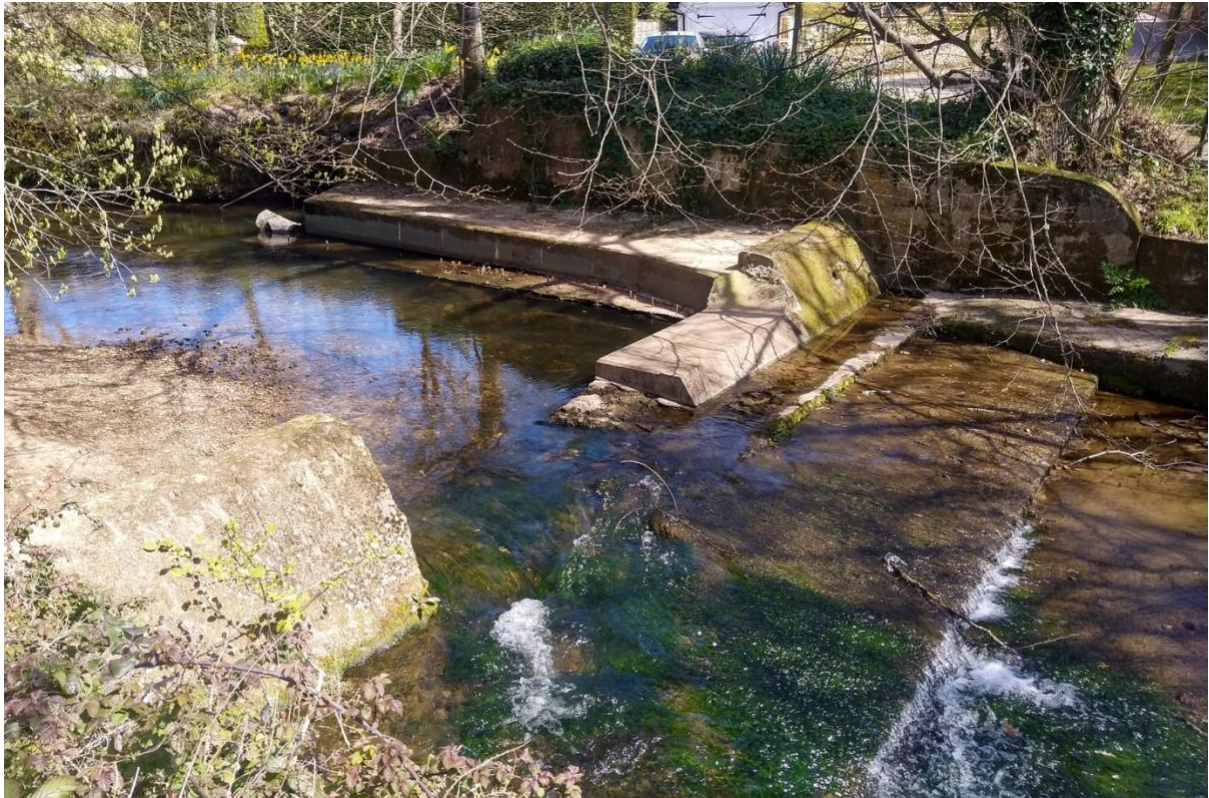
*Figure 17 Another old weir that has had a section removed. Despite this improvement for fish passage, the three shallow steps downstream are a significant impediment to fish passage. Total removal would be the best course of action. SY 12969 88498*

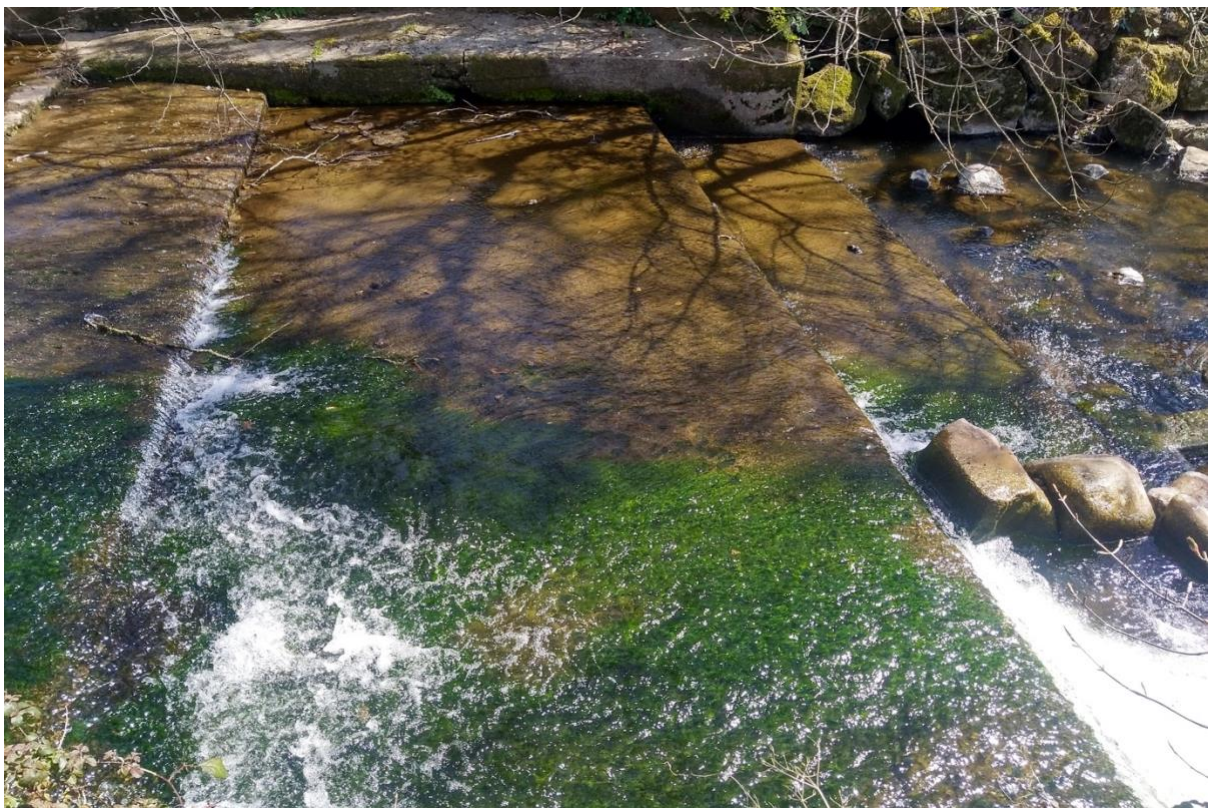
*Figure 18 The three shallow steps downstream of the weir in Figure 17. In low to medium flows, there isn't enough water for fish to swim upstream. SY 12969 88498*

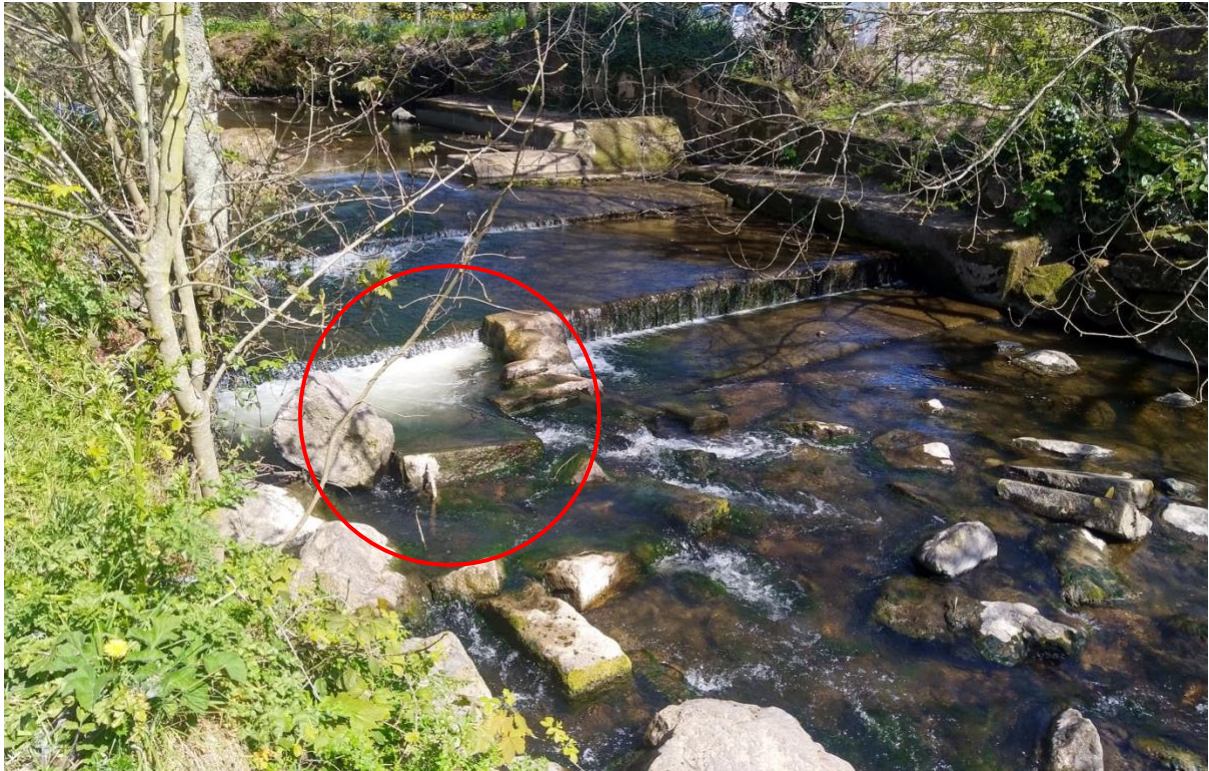
*Figure 19 Looking upstream to the weir in Figures 17 & 18. A notional jumping pool has been created to ease the first step (red circle), but overall insufficient to allow good upstream fish passage. SY 12969 88498*

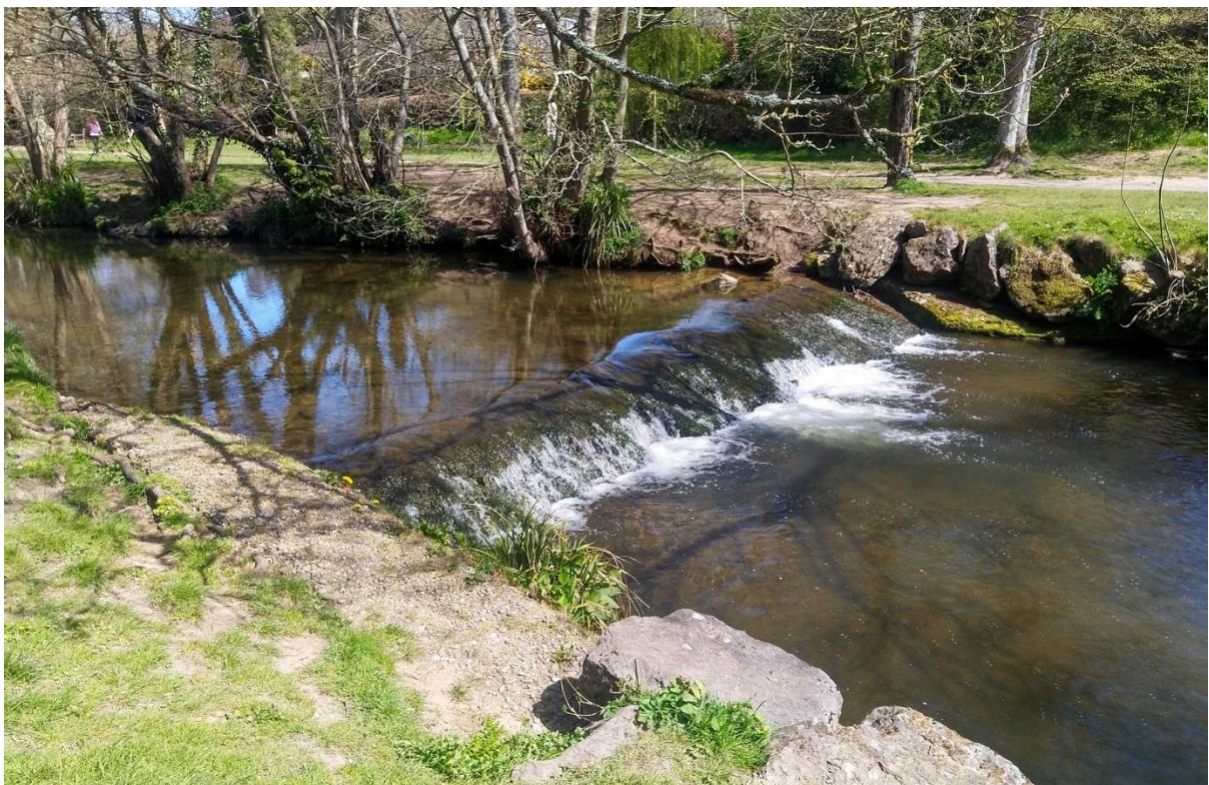
*Figure 20 A slightly more conventional Check Weir. Though not impassable, it still presents an unnecessary stress and delay to upstream and downstream migration. The impounded reach above is also severely lacking habitat diversity caused by the impoundment. Removal or significant alteration is recommended. Adding large woody material (LWM) would also be beneficial. SY 12880 88343*

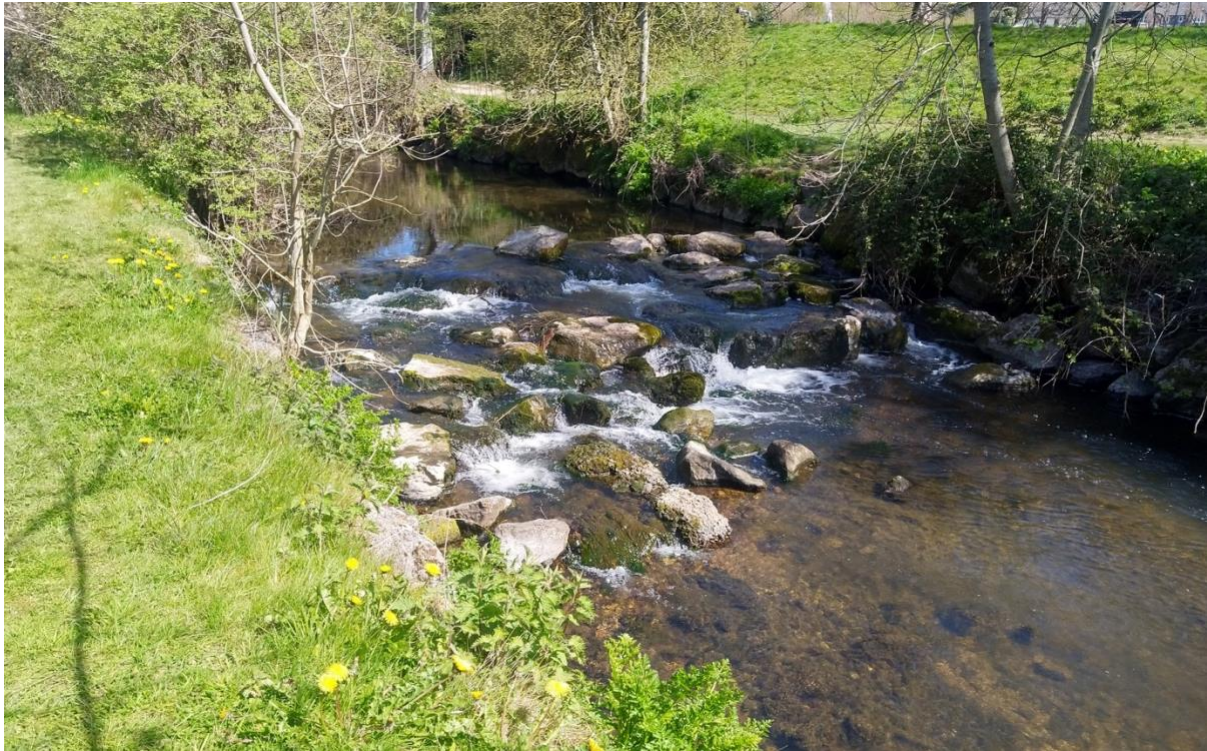
*Figure 21 A better looking rubble weir, though still an unnecessary impediment to natural river function and fish migration. With room on both banks, the gradient could be reduced through meandering rather than an unnatural step. This would restore a lateral scour pool and riffle sequence, good for all salmonid life stages. SY 12863 88312*

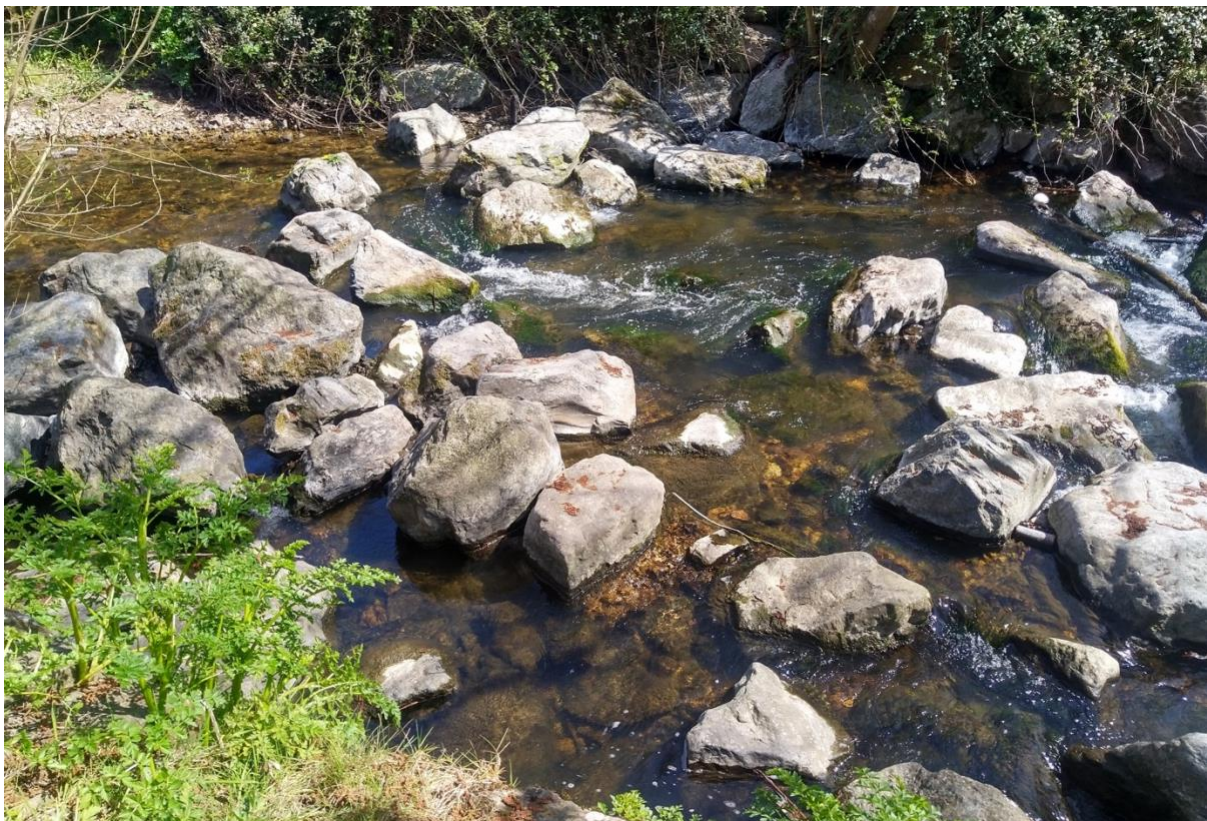
*Figure 22 Directly downstream of Figure 20, another reasonable rubble weir. Again, this could be made redundant (at least partially) through meandering. SY 12852 88305*

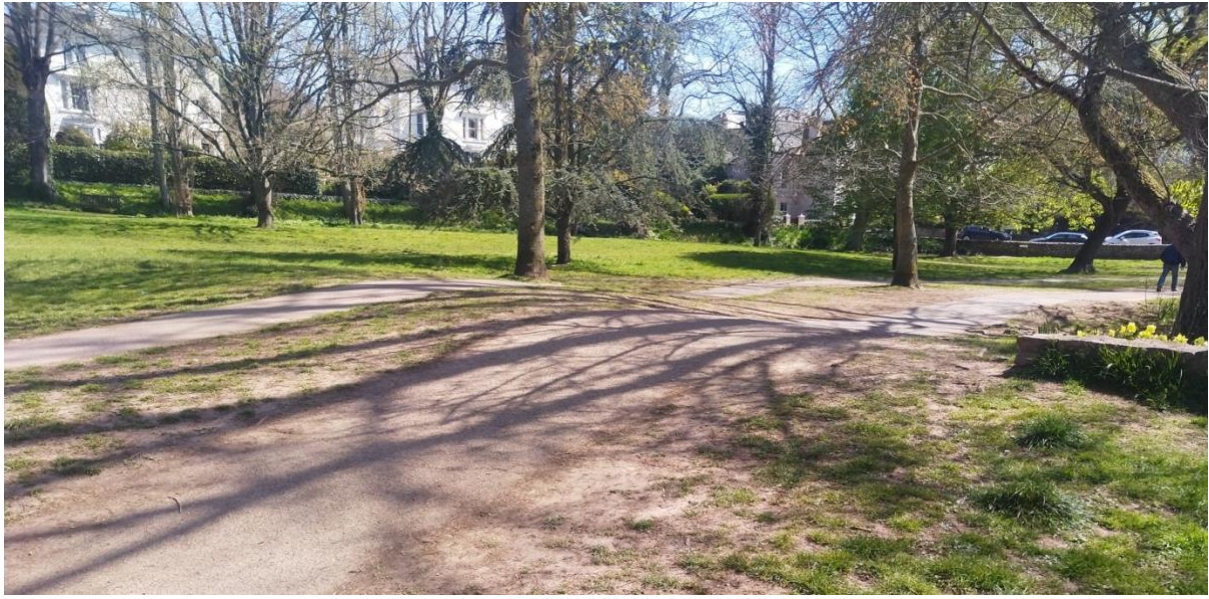
*Figure 27 The bund next to School Weir, designed to hold back flood water into the upper Byes. SY 12790 87895*

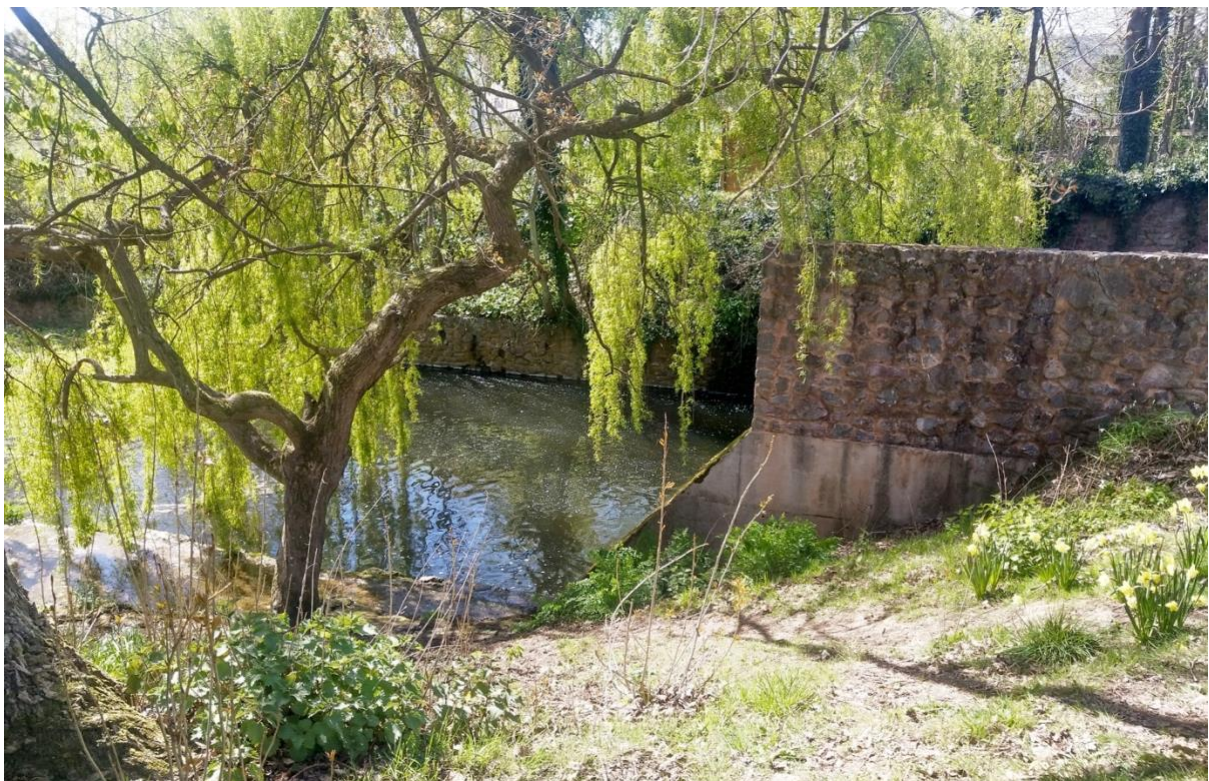
*Figure 28 The LB retaining wing wall of the School Weir seen from the top of the bund (Figure 27). SY 12790 87895*
