WILD TROUT TRUST

Upstream Extension of Sid Advisory Visit

This report is the output of a site visit undertaken 29 November, 2022 by Bruno Vincent of the Wild Trout Trust, along the River Sid in Devon, at the request of the Sid Valley Biodiversity Group. It forms an extension to a previous Advisory Visit by the same author dated 19 April, 2021 which can be found [here](https://dulavx8rjuiml.cloudfront.net/avreports/BVSidAV_2021-10-18-102137_ivev.pdf).
https://dulavx8rjuiml.cloudfront.net/avreports/BVSidAV_2021-10-18-102137_ivev.pdf

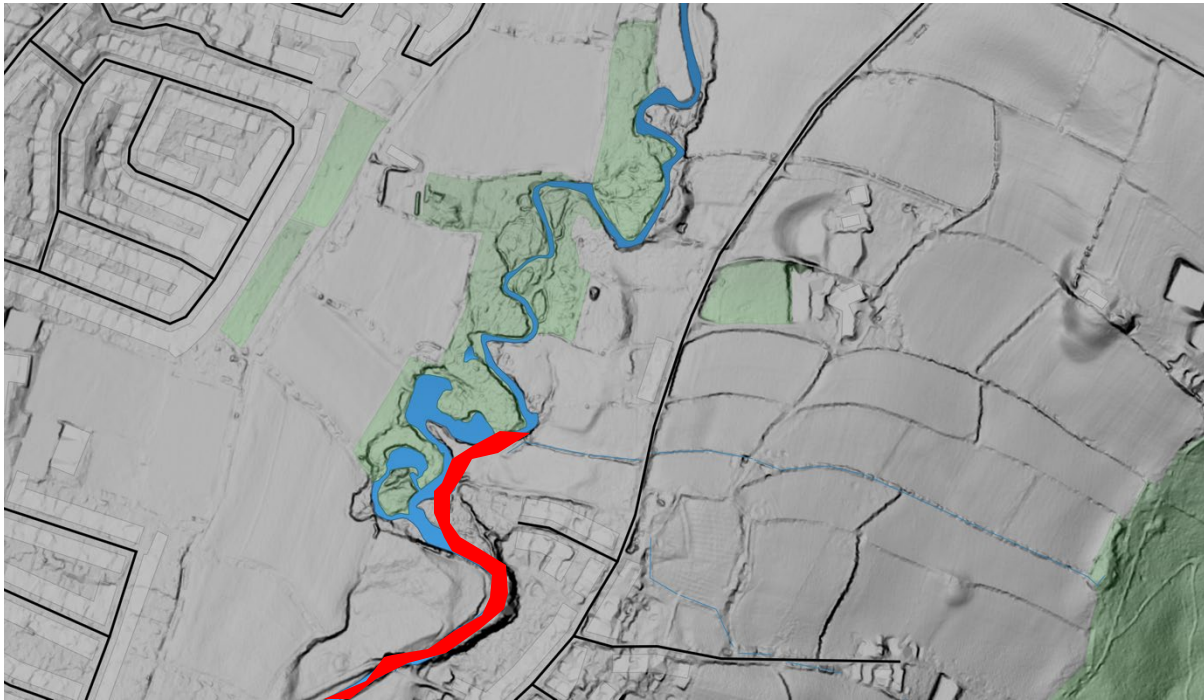
Map 2 A LiDAR map of the naturally meandering river above the reach inspected. The red shape roughly indicates the route of the channel on the day of visit. The isolation of the old meanders to the west is not uncommon, but the pace of change and sudden loss of habitat diversity is cause for alarm.

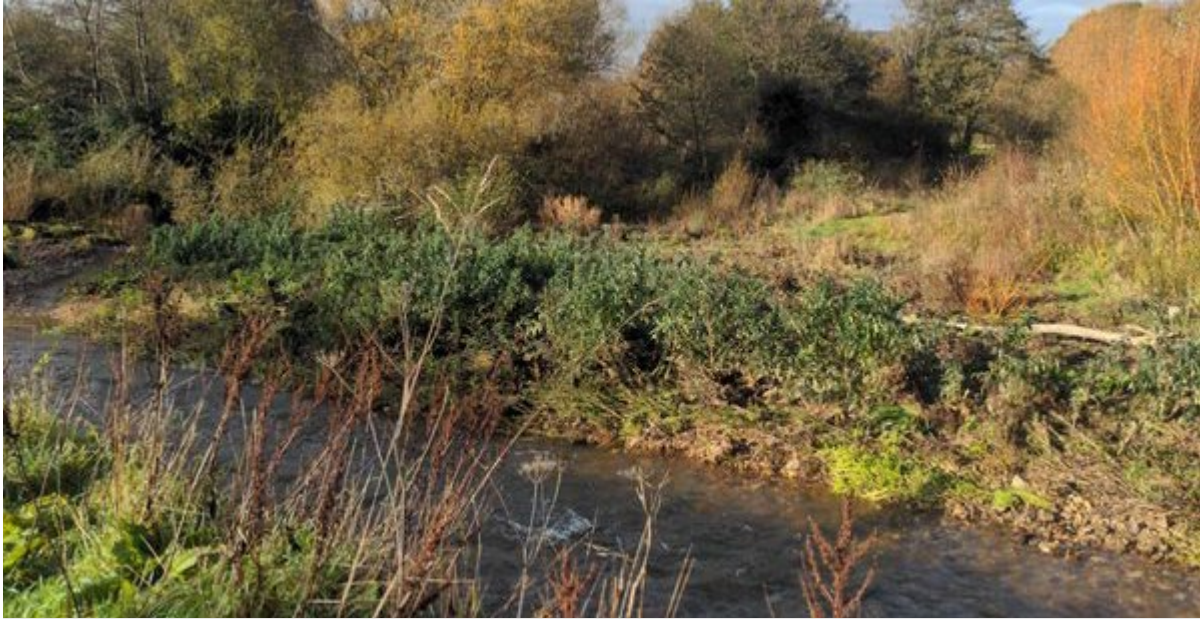
50.69690866 -3.22586566

The rapid morphological changes have deposited large amounts of sediment on what was recently the main channel. The fine sediment accumulating here has apparently carried buddleia seeds, which are now flourishing.

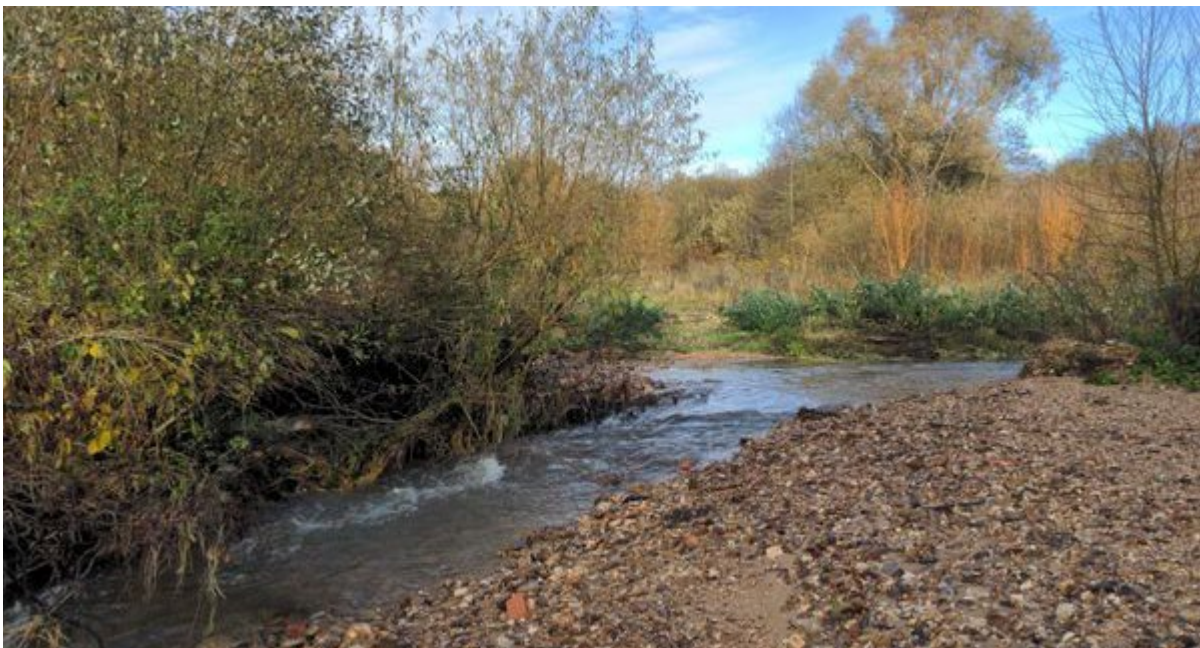
50.69672992 -3.22620241

Apparently, a new channel route as of one week ago, although map data suggest it has taken this course previously. The steep gradient is visible here, only arrested by small outcrops of bedrock.

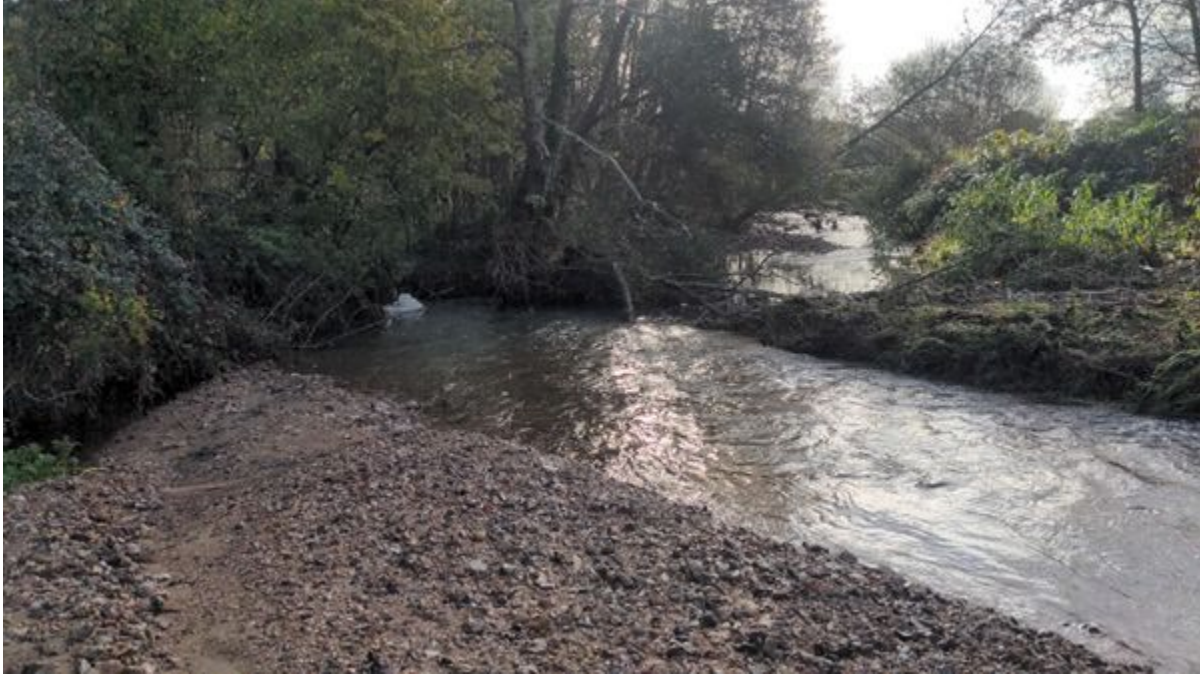
50.69672933 -3.22620117

A fallen tree is restricting the channel, with the potential to cause erosion on the LB, but this has been accepted and will find old channels within the wooded section downstream. The channel diversity this has created is adding to the habitat value, but similar man-made interventions must be sensitive as the lateral erosion they may cause could create unwanted land loss.

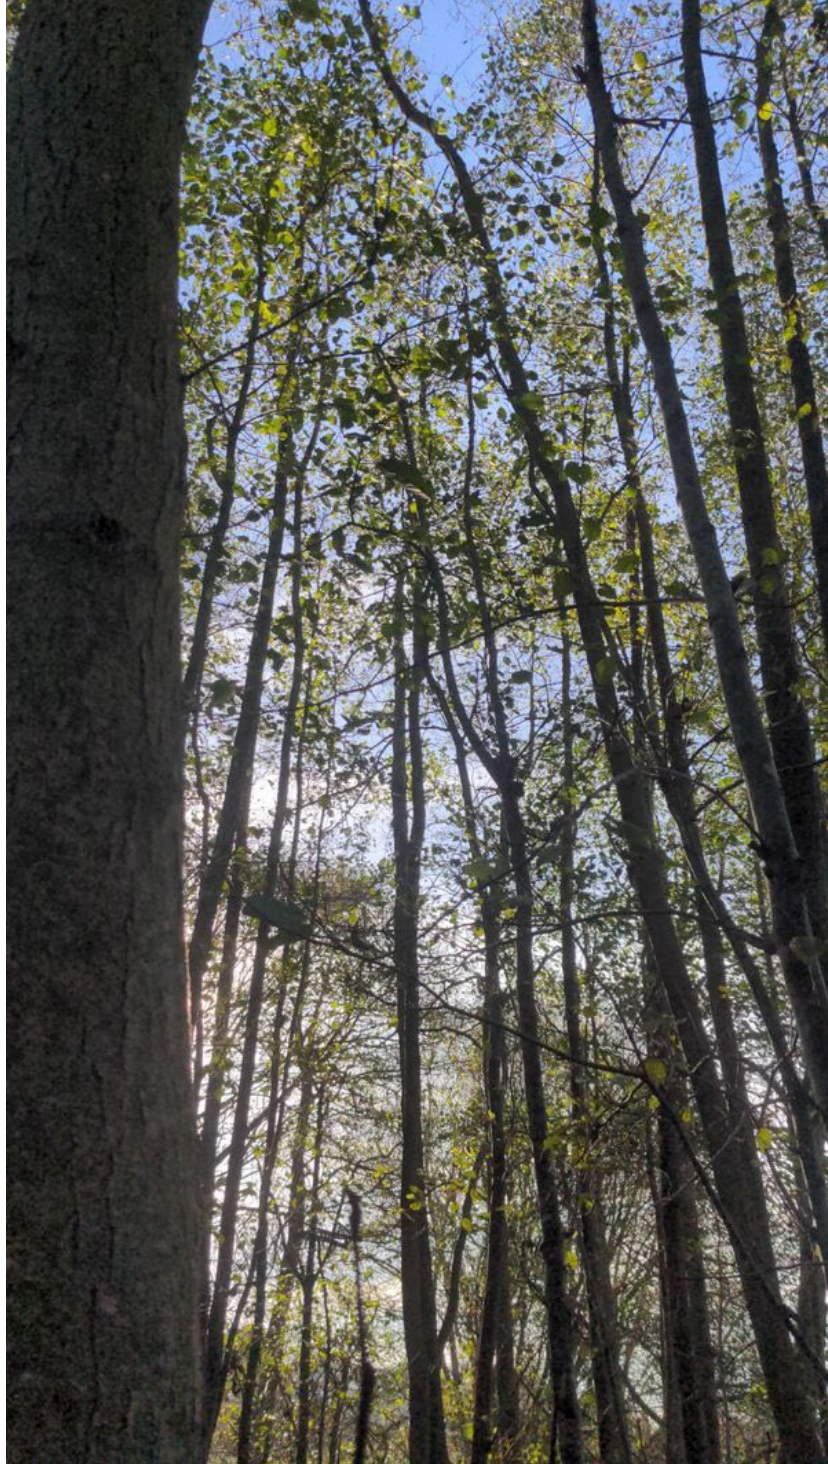
50.69644061 -3.22605739

Very tall and cramped tree growth on relief/paleochannels. This needs thinning for tree health, but arisings could be used as large woody material in channel to disrupt sediment transport.

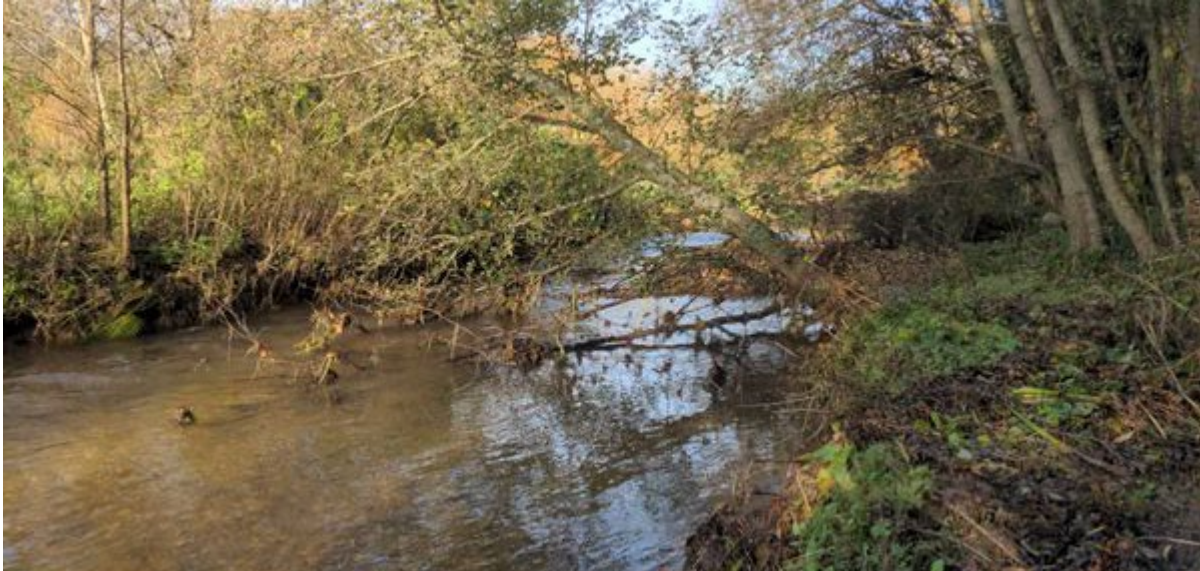
50.6963007 -3.22622681

Though pleasingly unkept with trailing cover, the channel gradient is extreme and pulling itself straight. With plenty of accessible floodplain in this area, adding woody debris to the channel will help hold back gravel, creating better habitat and improving floodplain connectivity. This alder will soon end up in the river and presents as a good opportunity to hinge D/S into the margin.

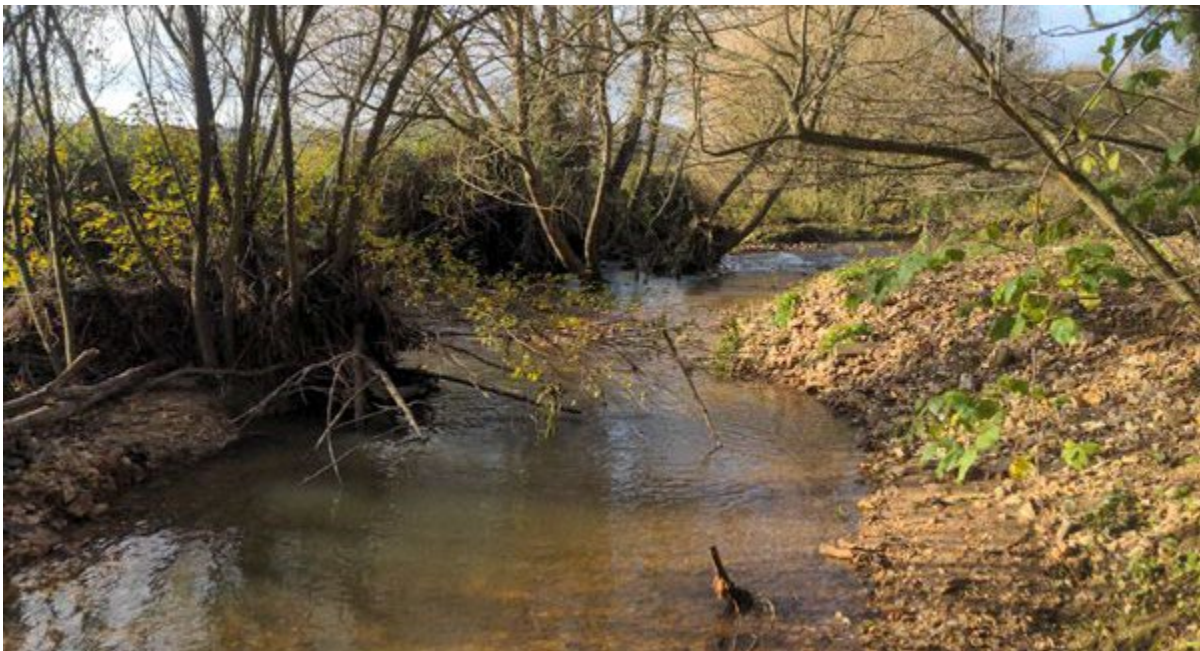
50.6960632 -3.22592355

Reasonable instream habitat but the high levels of coarse and also fine sediment suggest this area is changing fast.

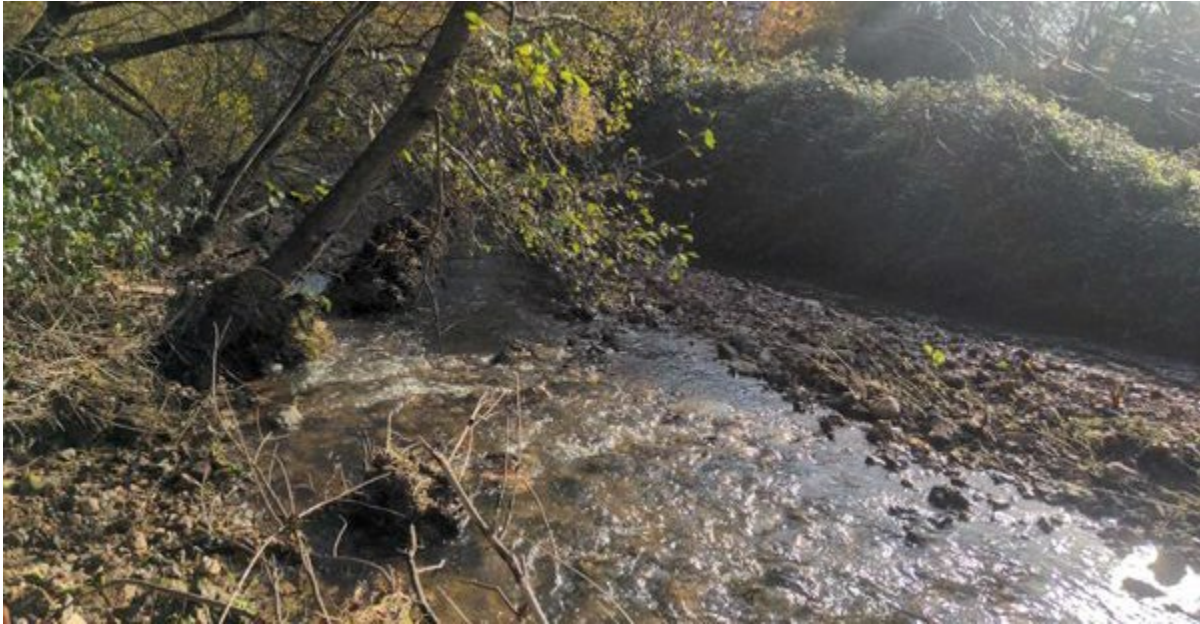
50.69606559 -3.22591796

Plenty of channel diversity, but significant tree loss is likely through bank collapse. Though this will provide habitat and structure to absorb energy, it is symptomatic of a rapidly changing river course. Again, another candidate for hinging D/S.

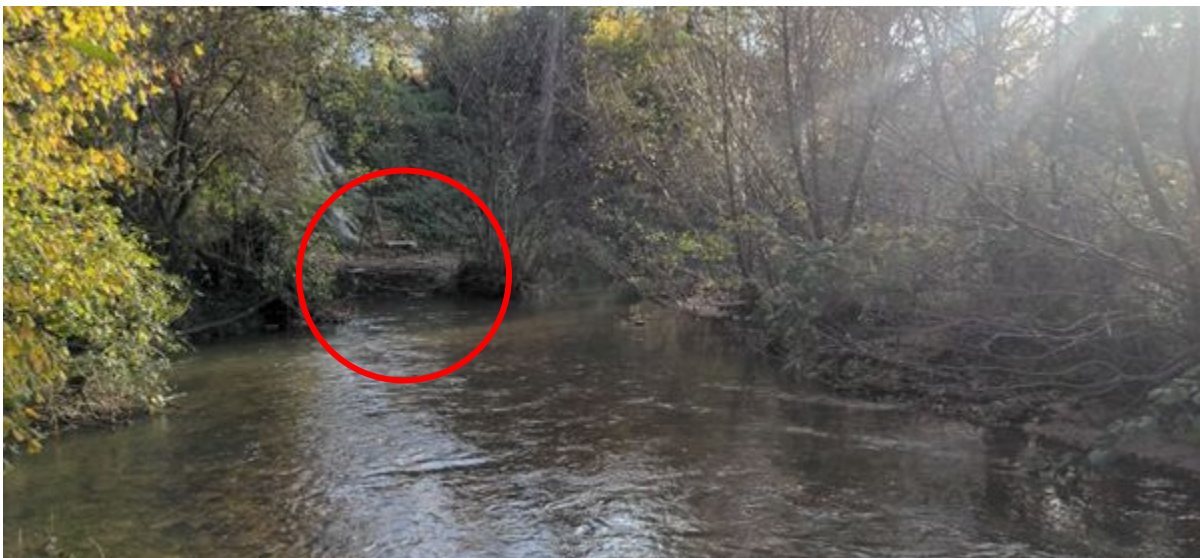
50.69592165 -3.22566722

A swing bench sits on a patch of land that is at risk from erosion (red circle). Green engineering in the form of a brushwood or LWD structure could protect this land whilst providing habitat and refuge, but ultimately the river is on a course toward the edge of the LB floodplain.

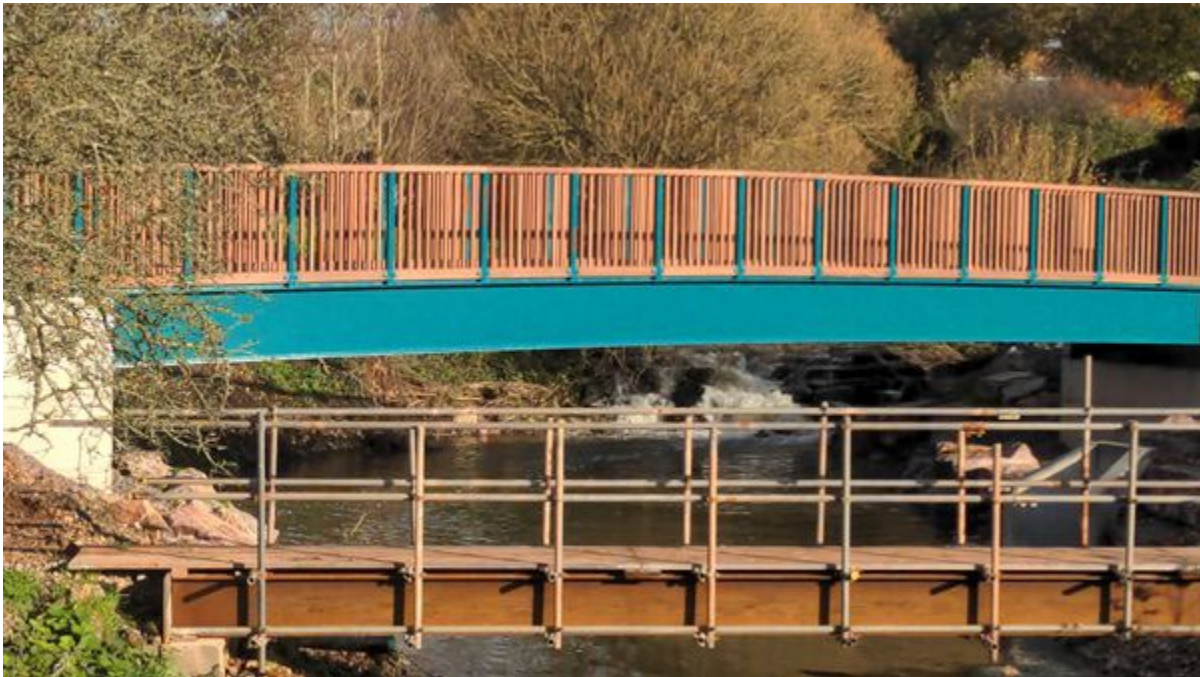
50.69489954 -3.2274672

Not accessible due to the construction site, a large weir, $\sim 1.5\text{m}$ height is seen upstream. This is considered impassable to fish passage and will have a negative effect on natural river function. Equally, it is holding the extreme gradient in check and so is likely essential. Sadly, the new bridge had presented an ideal opportunity to either address the weir or at least design a bridge around future alteration. Efforts should be made to find the best solution.

The proximity of the bridge and its footings to the weir upstream exclude the most favourable solutions for fish passage and natural river function. However, establishing dialogue with the bridge engineers is encouraged to layout a feasible scope of alteration.

As a 'loose structure', the weir could be better engineered. The ford upstream and the bridge downstream might add complexity to any fish passage solutions, but consultation should be instigated. Once the construction site is opened, closer inspection will be needed.

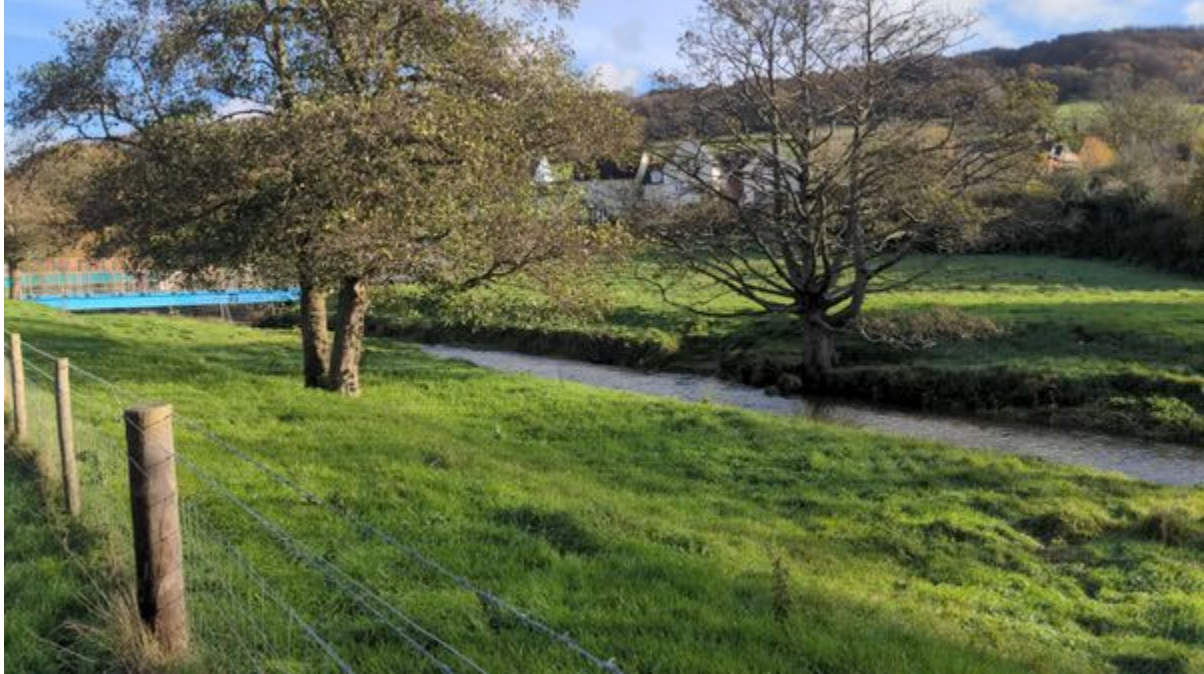
50.69472895 -3.22837358

A straightened and incised two stage channel. The edges of the original flood plain are visible on the RB (not clear in photo) suggesting that the river is sitting ~1m below its historic level.

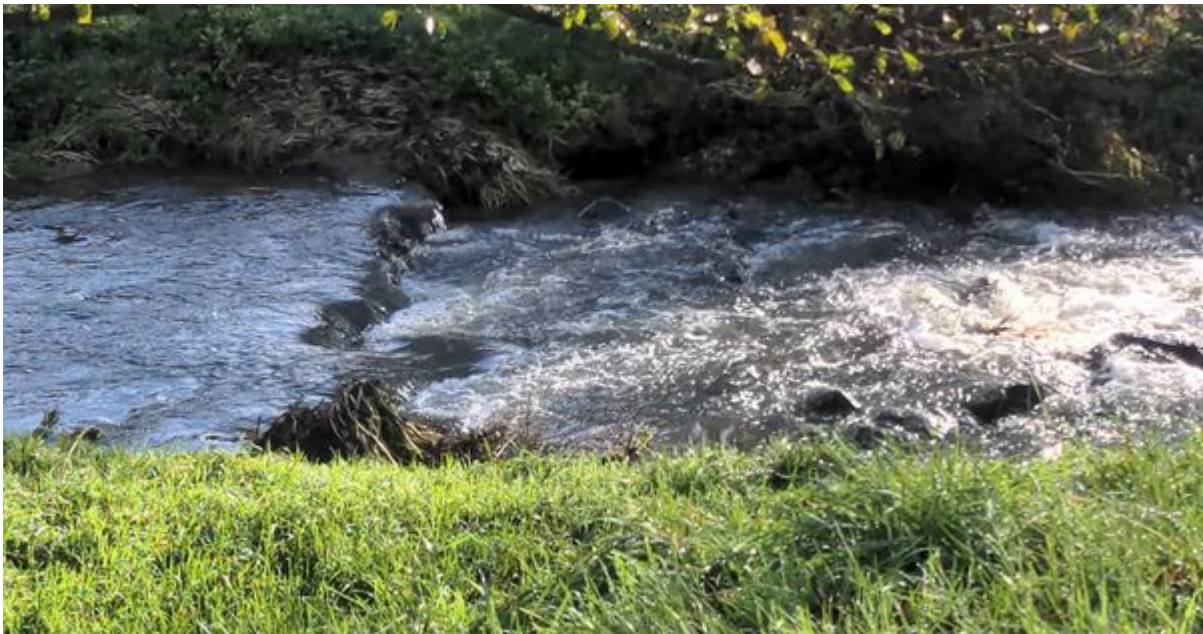
50.69468329 -3.22850652

A small check weir that poses little impedance to migratory fish. However, it is an unnatural structure, designed to slow sediment transport; as such it could be improved with greater variance in flow paths.

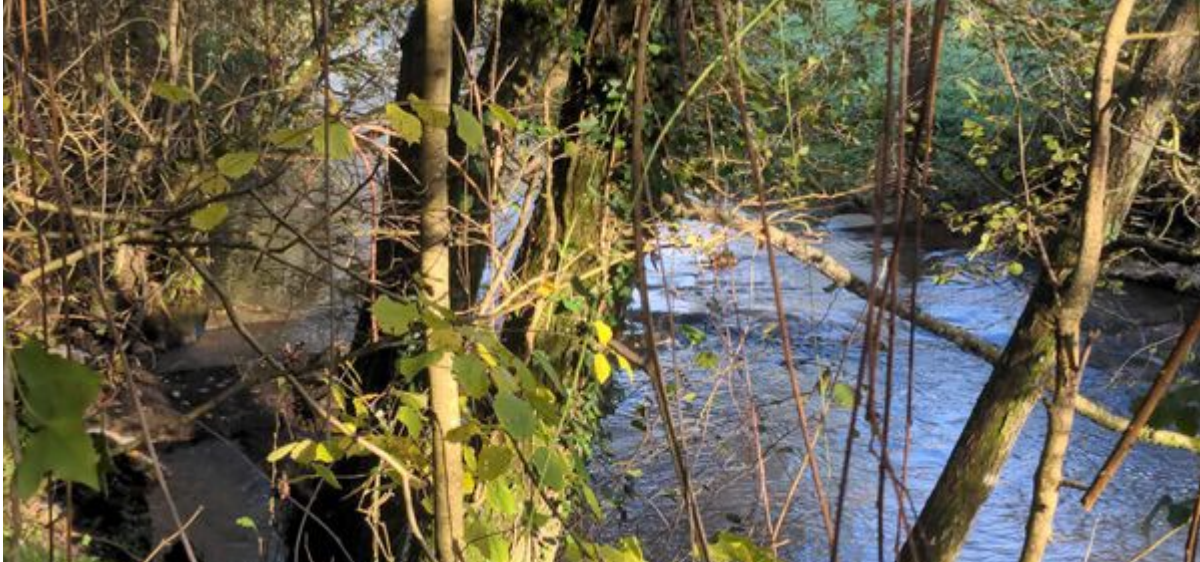
50.69427707 -3.22880583

Another small structure, though difficult to photograph, it appears to have broken up over time. This could be beneficial in terms of natural river function, but detrimental due to increasing erosive forces on the bed.

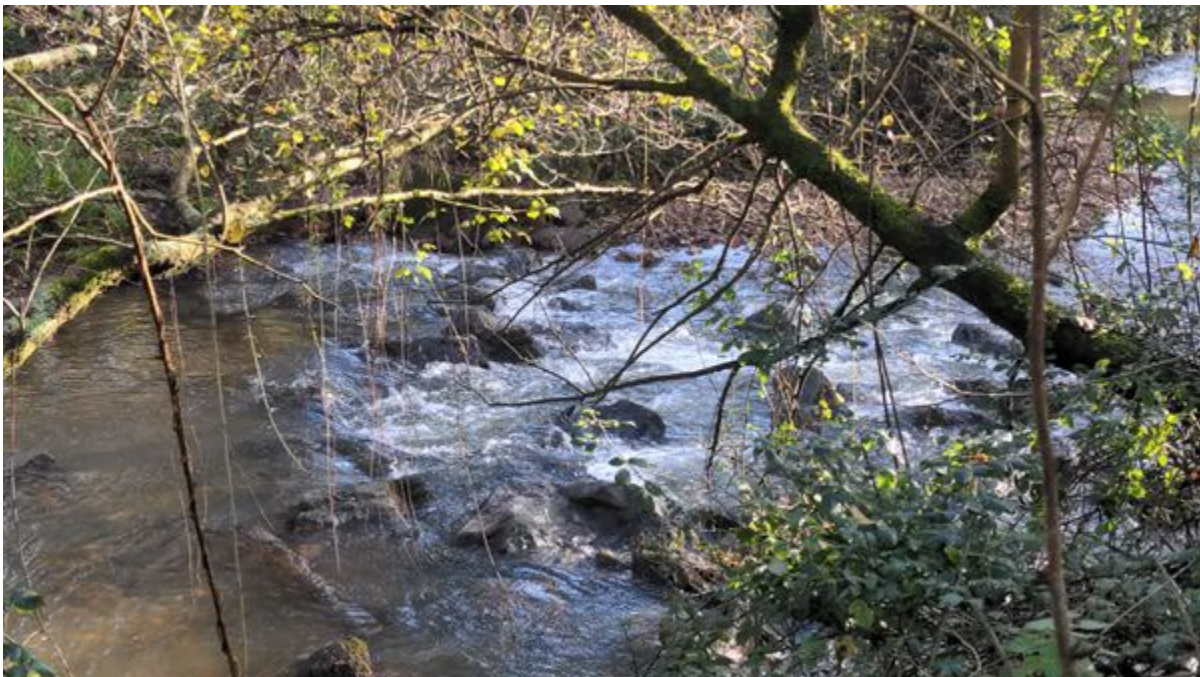
50.69425912 -3.22885055

Despite sweeping through a couple of reasonable bends, the river still drops at an alarmingly fast rate. This check weir is likely necessary to interrupt the gradient and thankfully represents a rock ramp formation that would be OK for fish passage. It could be improved with the movement of select boulders though this should be analysed in lower flows.

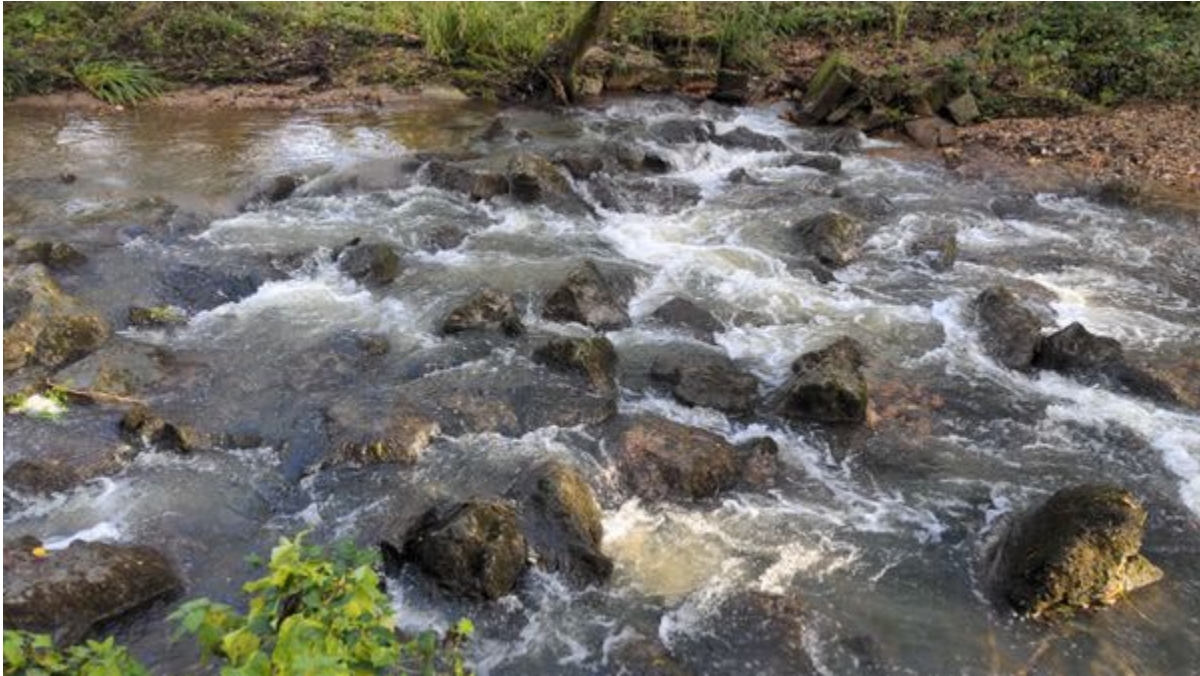
50.69415324 -3.22878967

Very similar to the previous photo, this check weir is more akin to a rock ramp. Careful replacement of some boulders, with a test, evaluate and reiterate process will maximise the potential for easy fish passage.

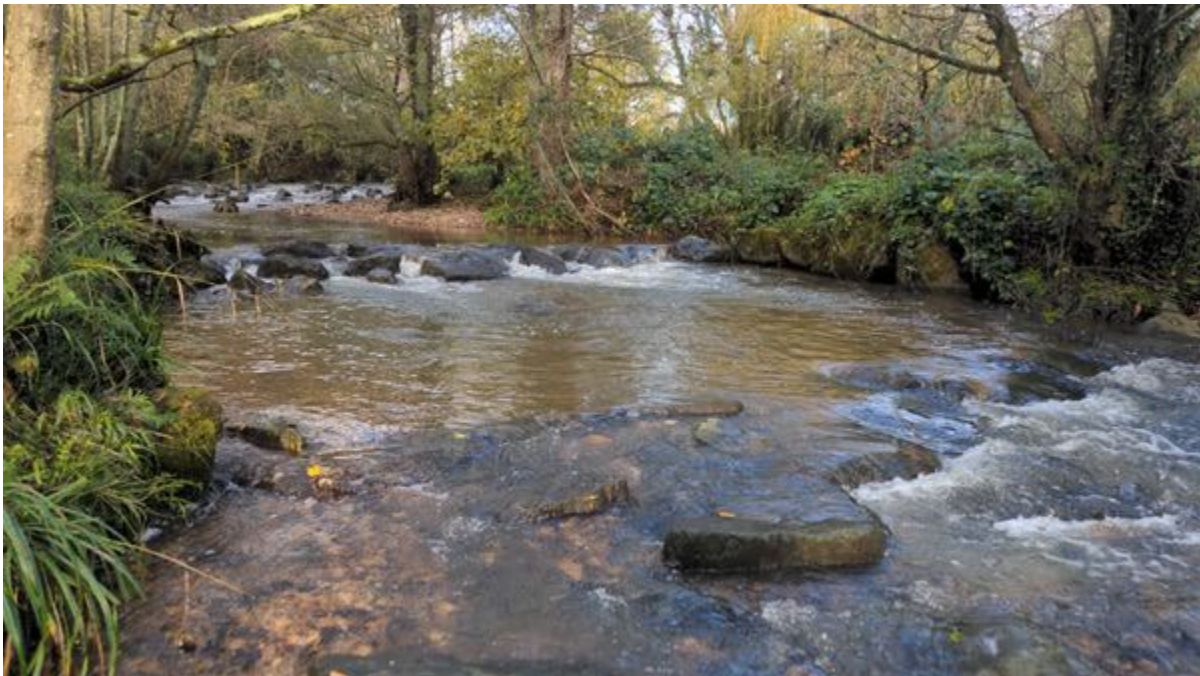
50.69385314 -3.22870742

Looking upstream at a cascade of four weirs, including the previous photos. This also marks the upstream limit of the previous Advisory Visit walkover.

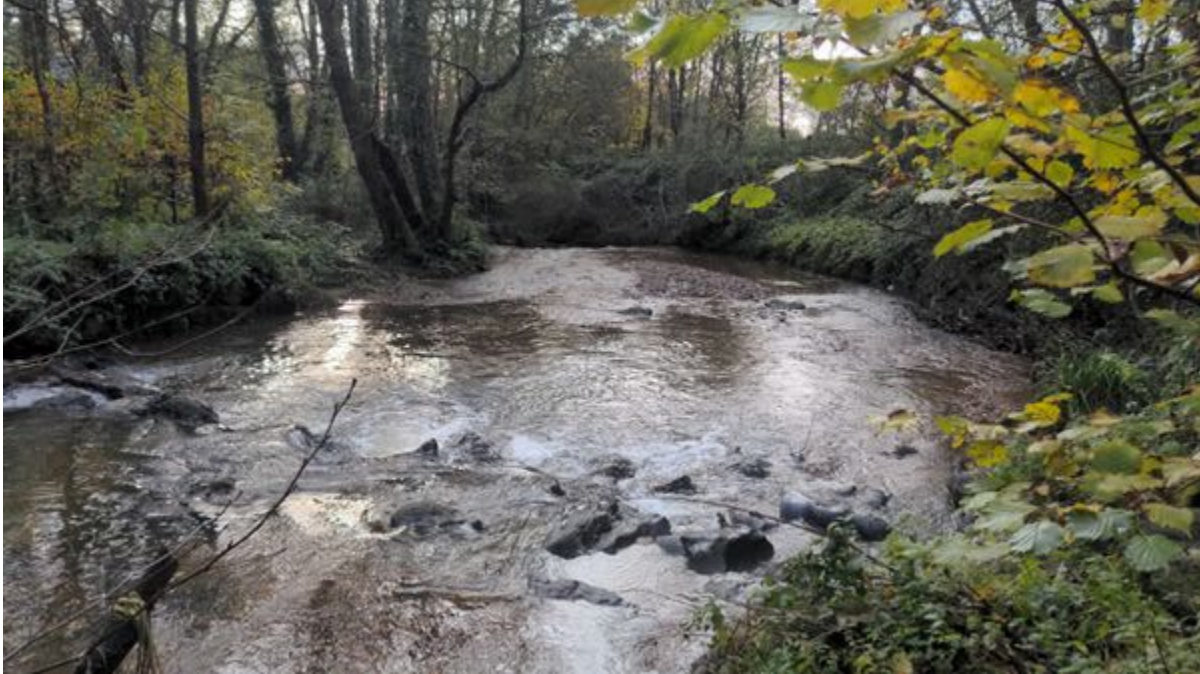
50.69340028 -3.22881147

A good example of how large in-channel structures can have a larger downstream effect. The two boulders mid-stream have reduced energy enough to allow a gravel bar to form mid-stream. For the most part, the river inspected was without much complex structure (other than the check weirs), leaving homogenous habitat along much of the reach.

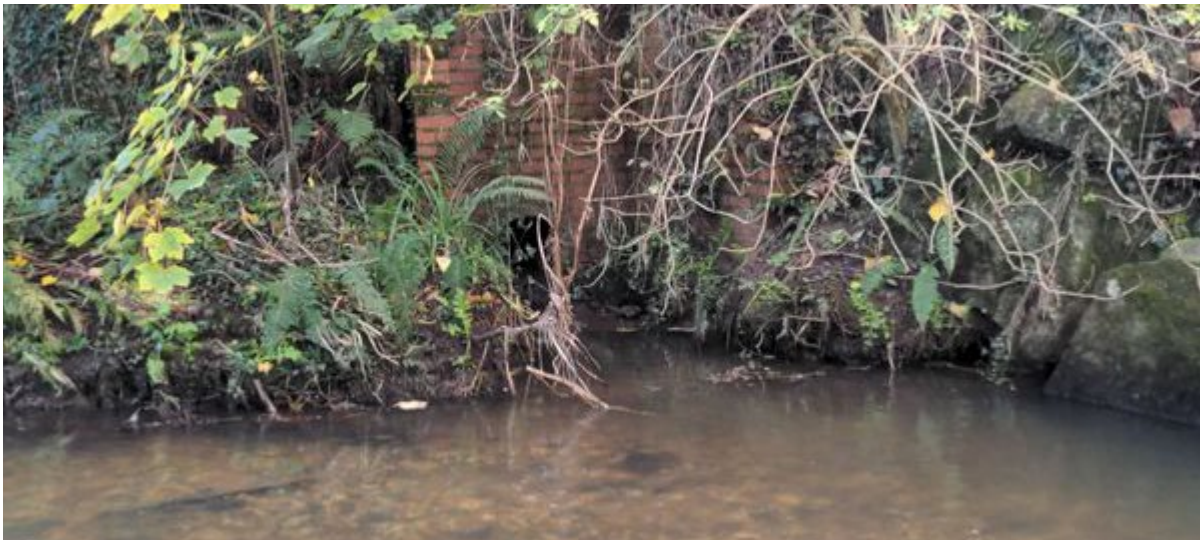
50.69096538 -3.232263

An outfall that was previously unnoticed. Investigation as to its purpose and necessity is advised.

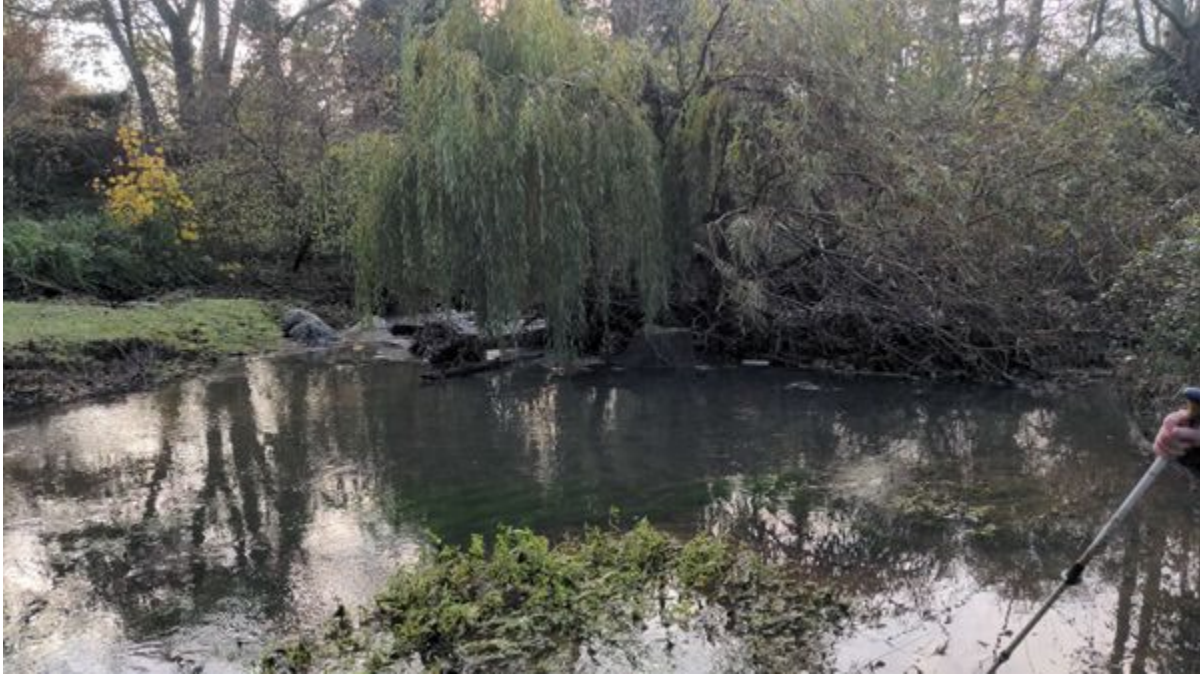
50.69128848 -3.23161272

A fallen willow lies across another boulder weir. Though not visible on the far bank due to access, it is likely sending greater flows over the LB half of the weir. This should improve migration potential in lower flows, but will likely cause unwanted erosion on the LB.
