WILD TROUT TRUST  
wildtrout.org

## Advisory Visit River Sid, Devon

April 19, 2021

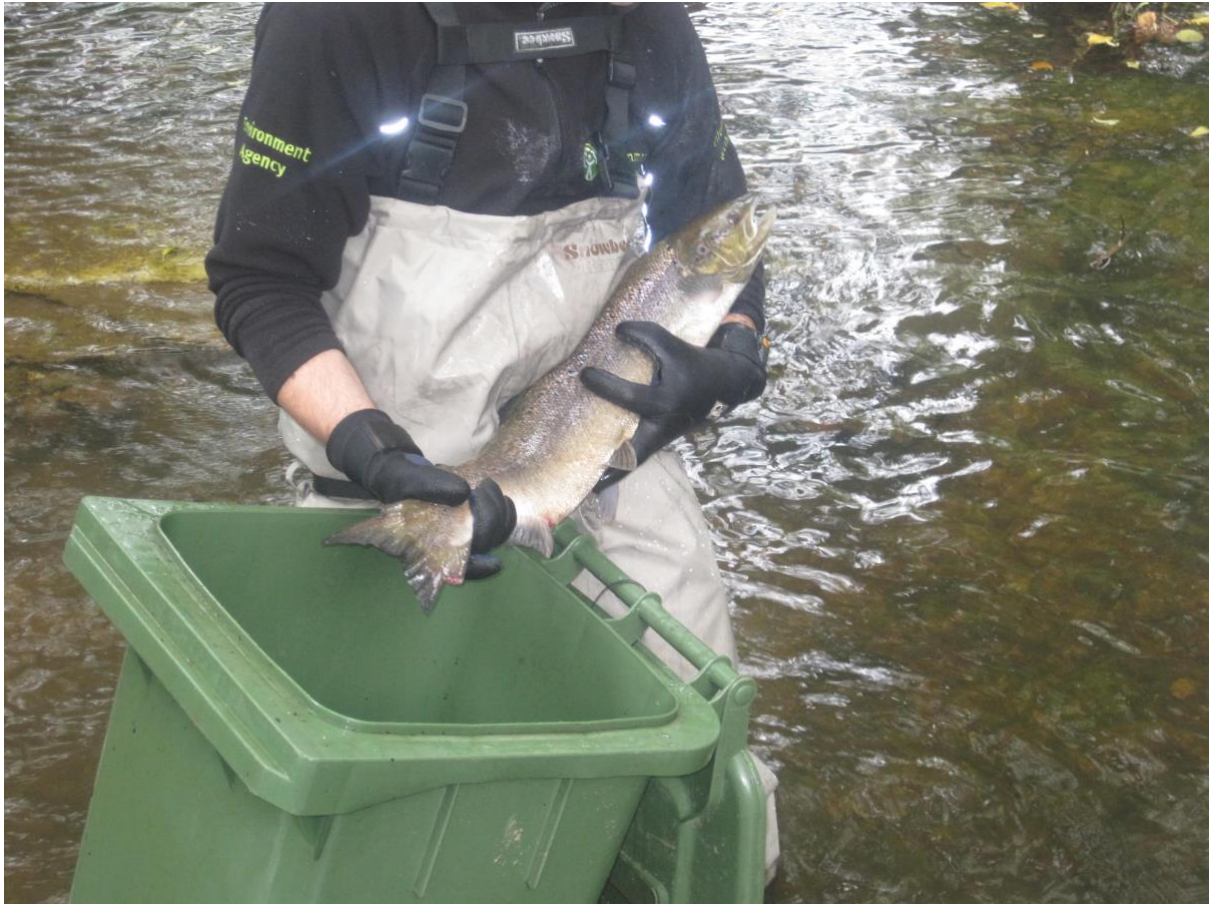
wheelie bins. They requested appraisal of options to improve fish passage through the weir (Figure 2).

*Figure 2 An Environment Agency officer loads a salmon into a wheelie bin as part of the Sid Vale Association's work to translocate migratory fish upstream of School Weir.*

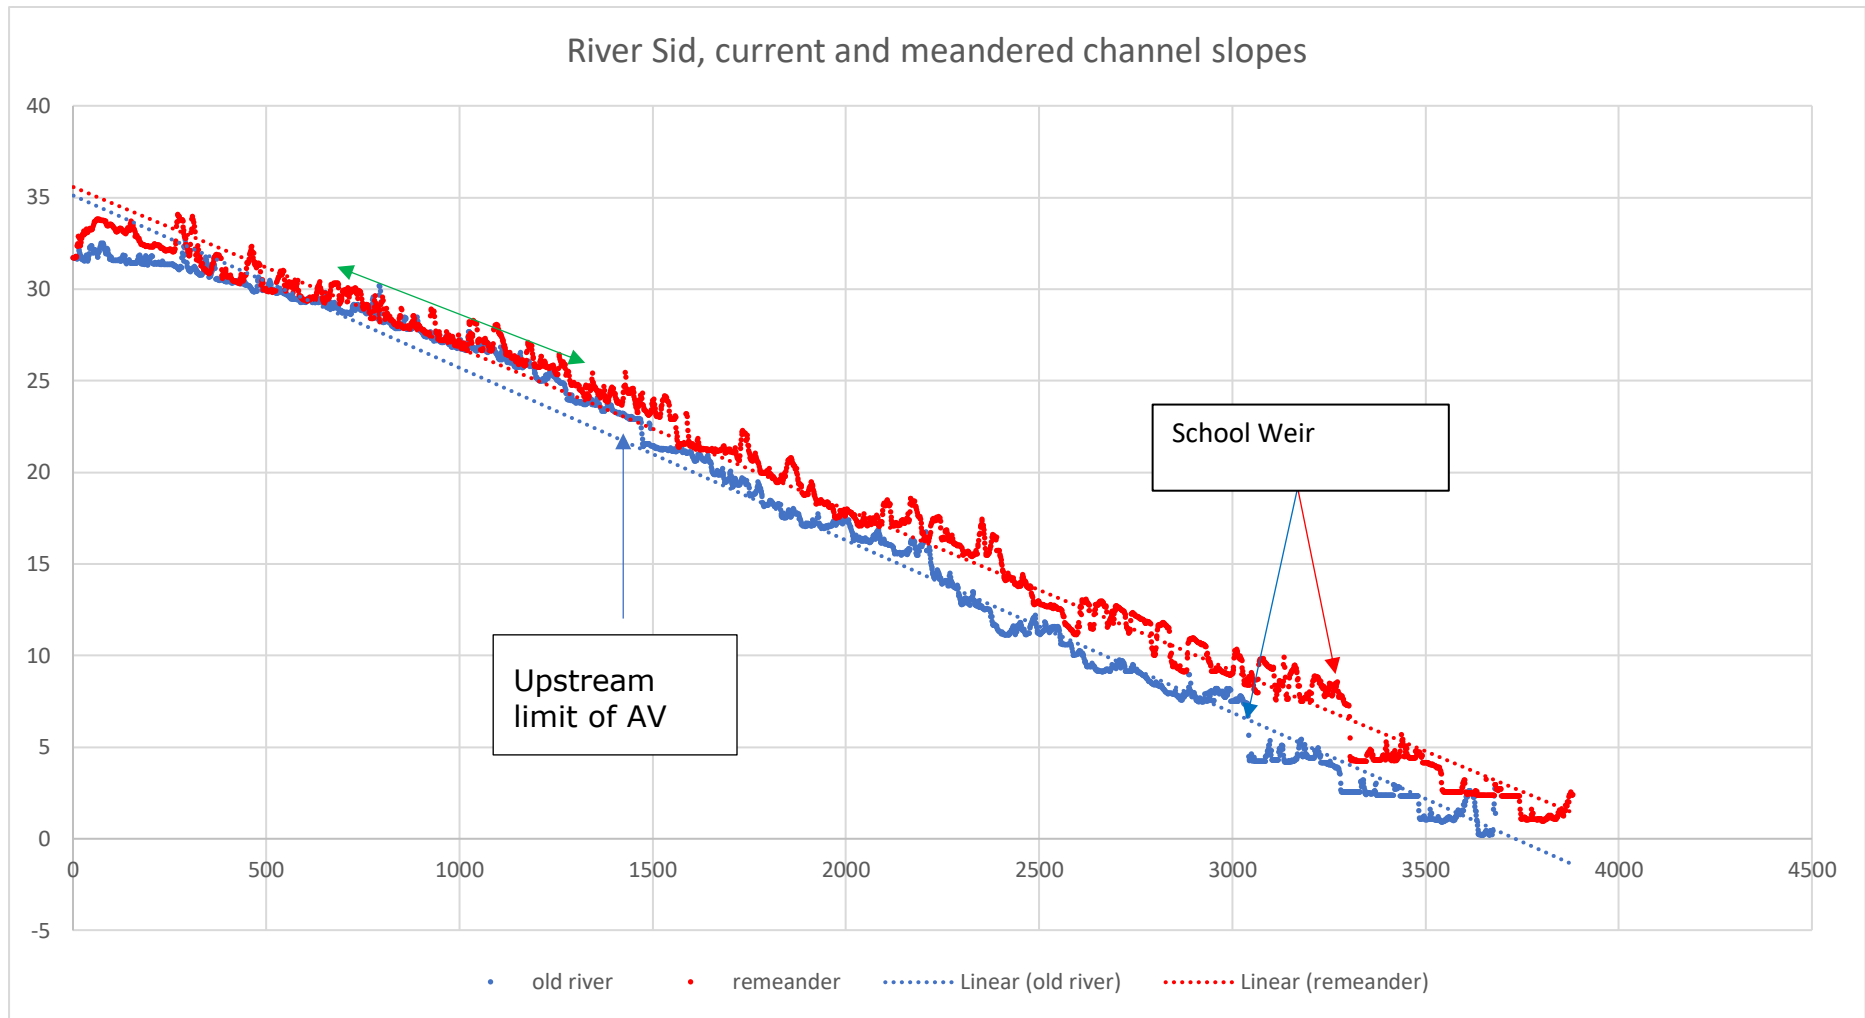
Chart 1 The slope of the current channel (blue) and a conceptual meandered channel (red). The current gradient increases noticeably at 1500m, whereas the new channel maintains an average gradient throughout. Note the green arrows which roughly indicates the meandering channel above the reach inspected Shown in Map 2. Its current gradient is broadly similar to the meandered channel. Also the number of flat sections to the current river, that indicate the areas of impoundment caused by weirs. The noise in the red is caused by the meander form picking up spot heights from the higher river bank.

With the current course, from Sidbury to the sea, having an approximate gradient of 1 in 100 re-meandering could reduce this by approximately 7% but the measures to establish this will also increase hydraulic roughness, further decreasing discharge (Chart 1). As such, allowing lateral erosion will have a net benefit to flow reduction, habitat value and slowing the bed erosion.
