WILD TROUT TRUST

Upstream Extension of Sid Advisory Visit

This report is the output of a site visit undertaken 29 November, 2022 by Bruno Vincent of the Wild Trout Trust, along the River Sid in Devon, at the request of the Sid Valley Biodiversity Group. It forms an extension to a previous Advisory Visit by the same author dated 19 April, 2021 which can be found [here](https://dulavx8rjuiml.cloudfront.net/avreports/BVSidAV_2021-10-18-102137_ivev.pdf).
https://dulavx8rjuiml.cloudfront.net/avreports/BVSidAV_2021-10-18-102137_ivev.pdf

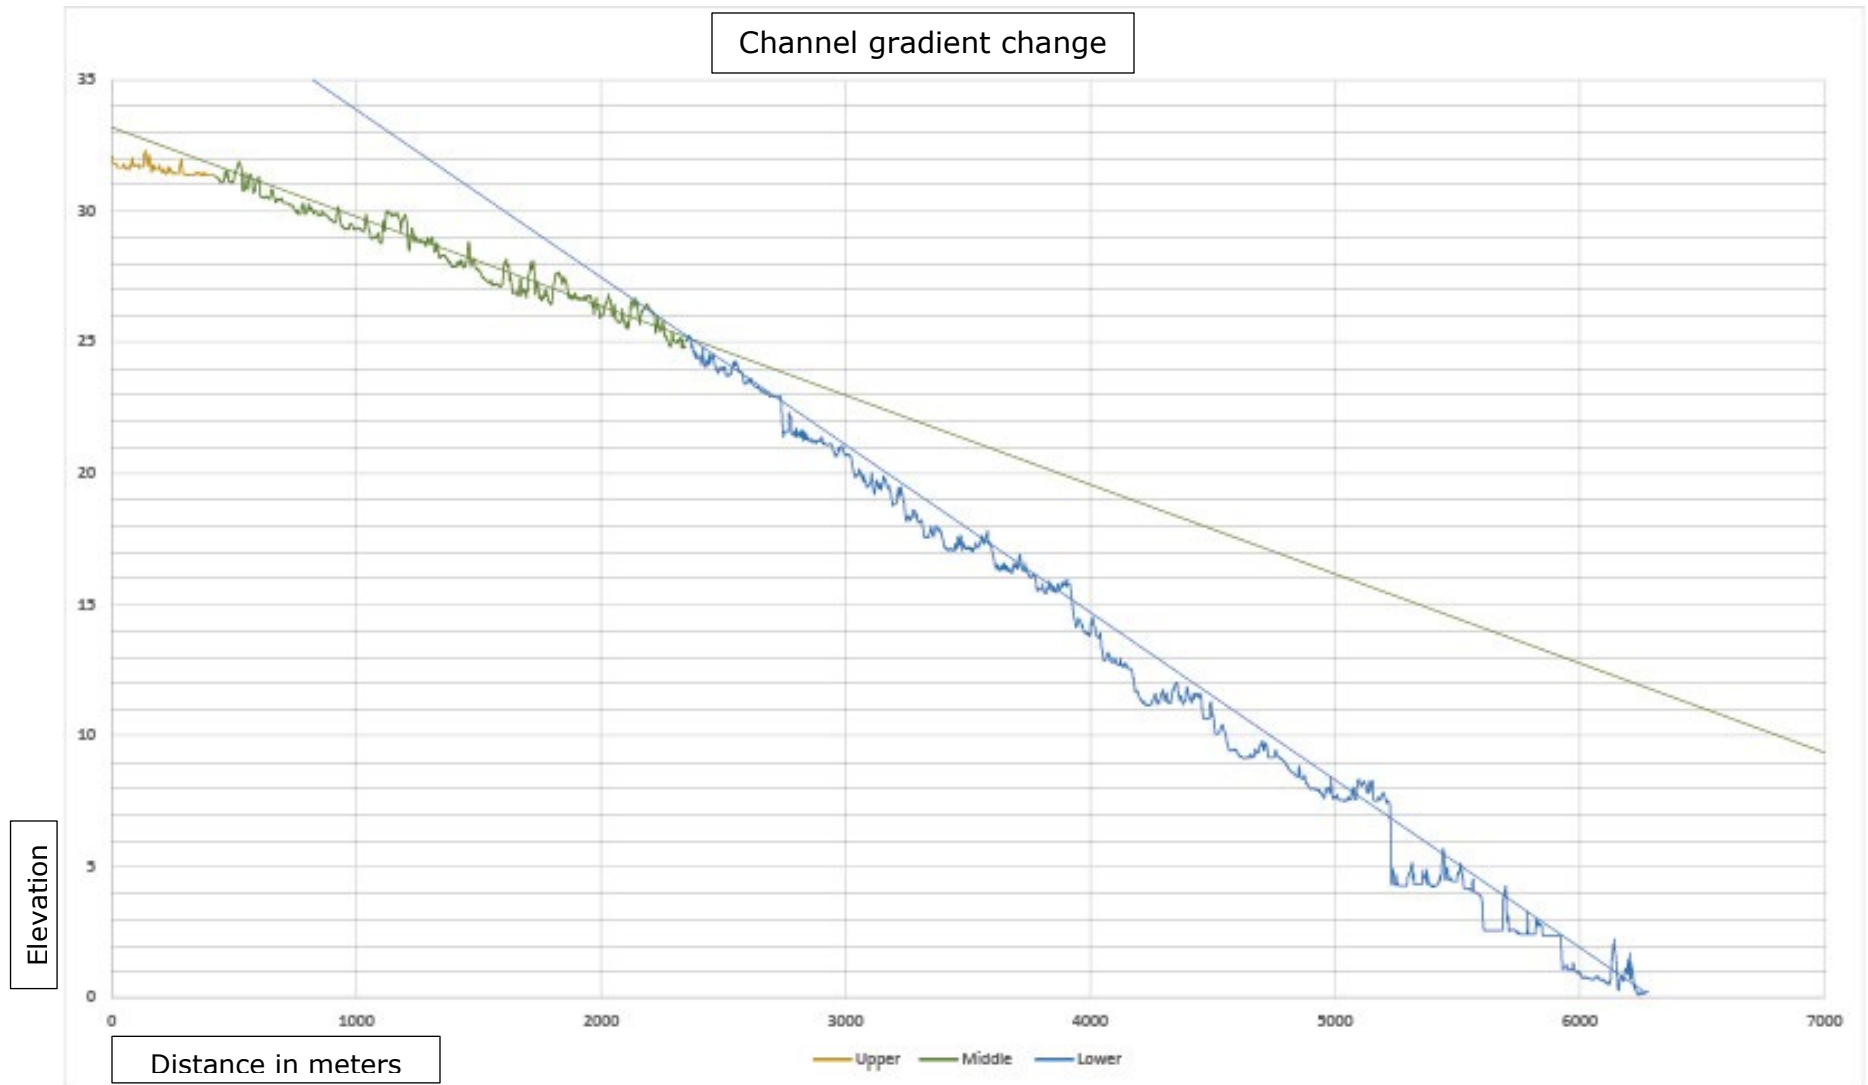
Figure 1 The profile of the Sid from the A3052 bridge to the sea. The green trend line indicates the average gradient through the meandering reserve, with the blue trend line showing approximately twice the rate of fall downstream. Spot heights taken from LiDAR DTM along channel.

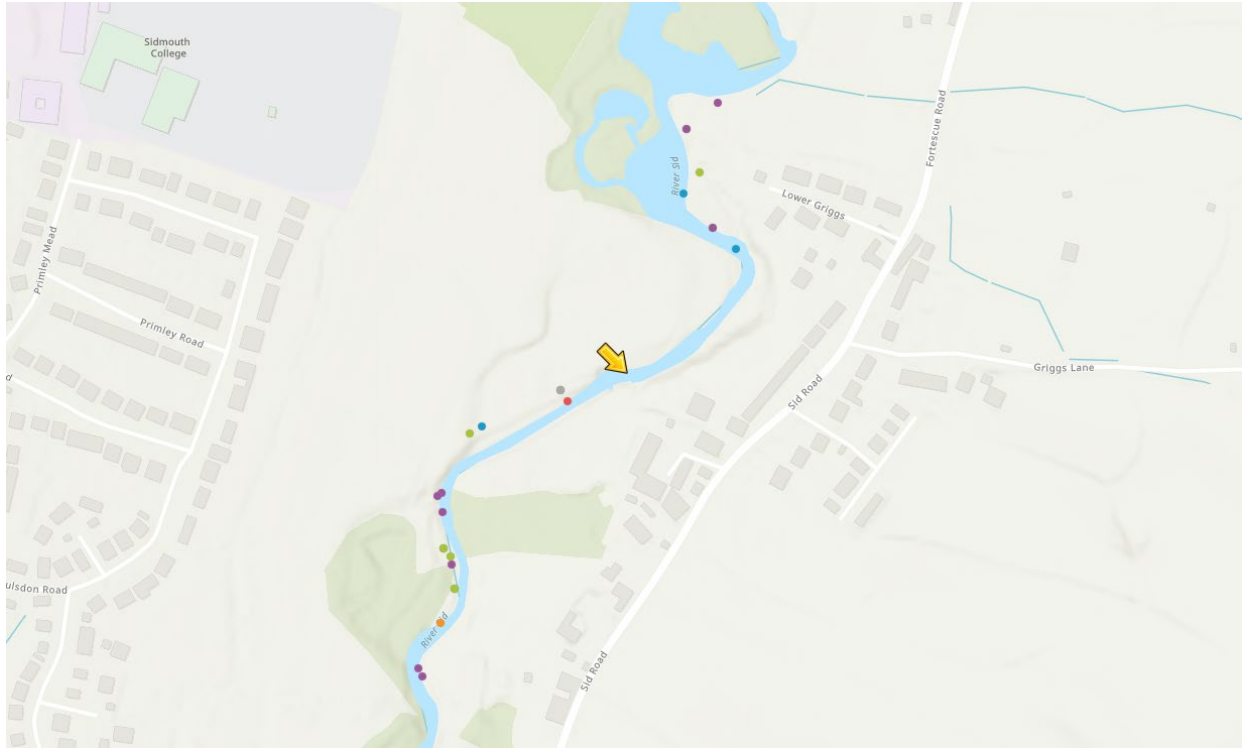
Map 3 Map showing the location of Fortescue Weir (yellow arrow).

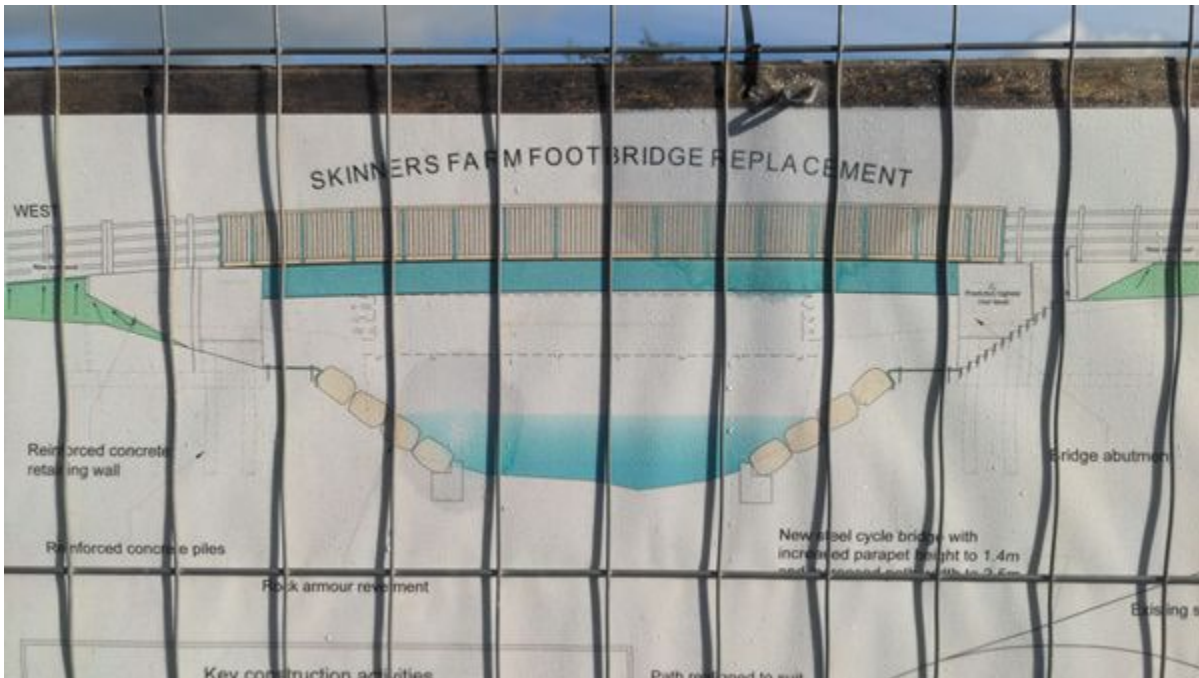
50.69497305 -3.22754045

A drawing of the new Skinners Farm Foot Bridge.

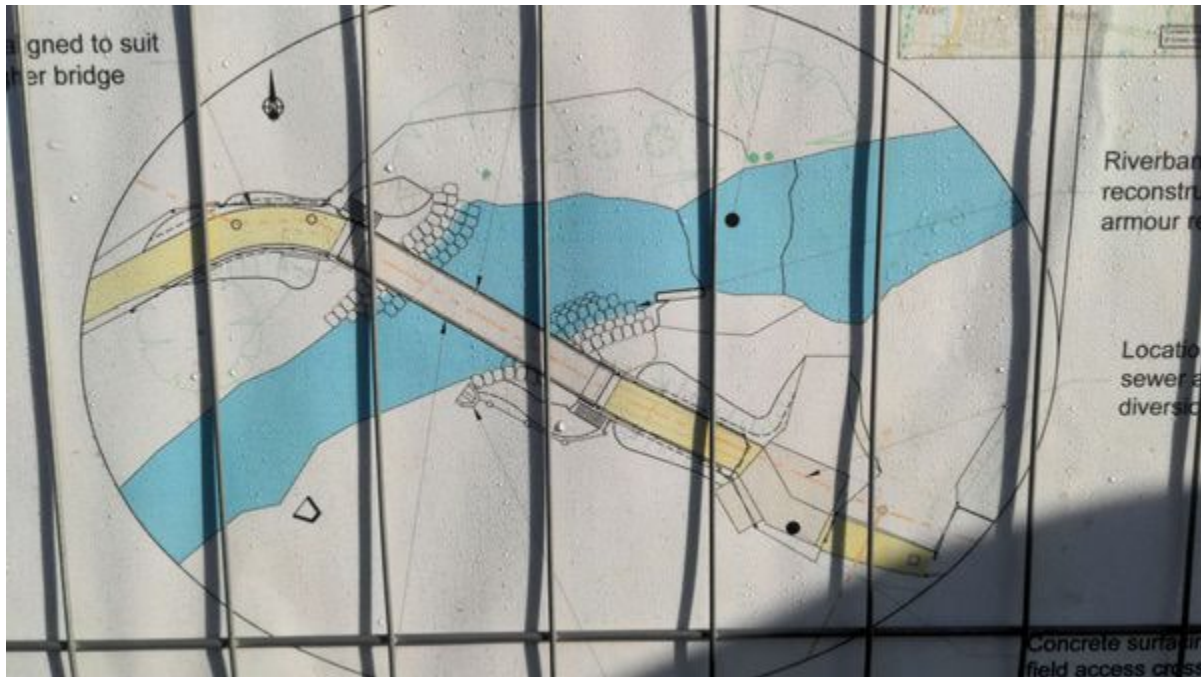
50.69497362 -3.22754271

Plan view of the Skinners Farm footbridge.

As a 'loose structure', the weir could be better engineered. The ford upstream and the bridge downstream might add complexity to any fish passage solutions, but consultation should be instigated. Once the construction site is opened, closer inspection will be needed.
